# **NOTTAWASAGA RIVER SHOREWALL STANDARDS**

**December 2014**

**Prepared for  
THE TOWN OF WASAGA BEACH**

**NOTTAWASAGA RIVER  
SHOREWALL STANDARDS**

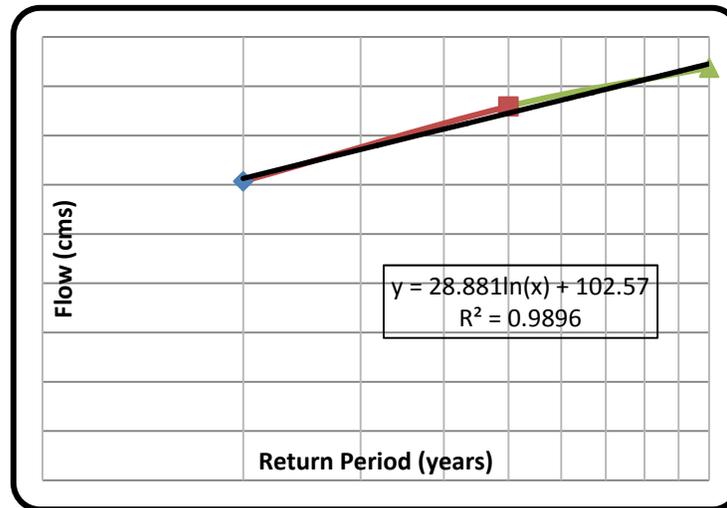
Figure 4: Flow Regression Analysis for Nottawasaga River at Wasaga Beach

Typically, bankfull return periods have been associated with 1:1.5 year return period. The existing return period flows presented in Section 2.2.2 were regressed. The resultant 1:1.5 year return period flow is expected to be 114.3 m<sup>3</sup>/s (see Figure 3).

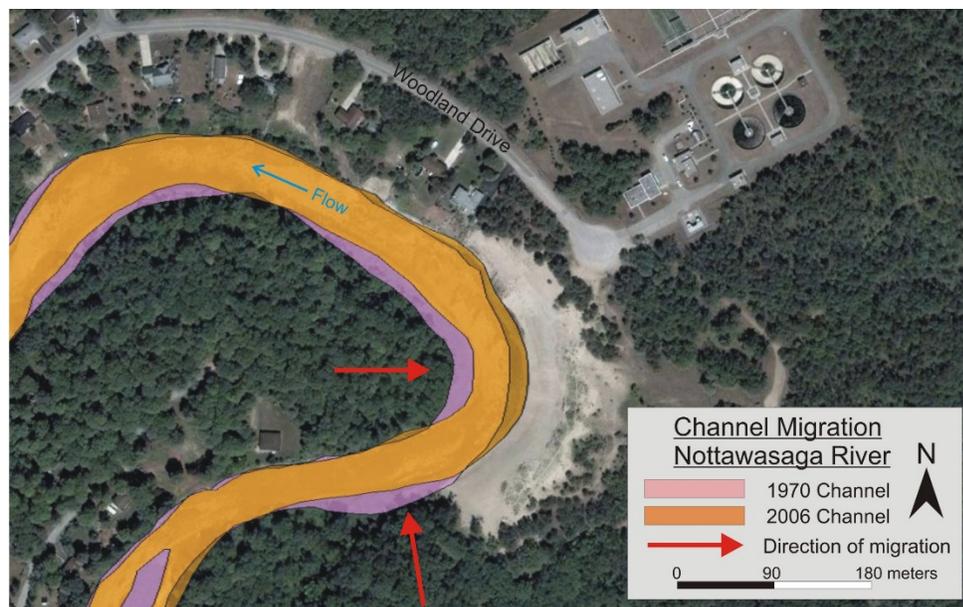
**Figure 5: Measurable Bank Migration Within the Vicinity of Woodland Drive.**

Within the study area, sites of excessive erosion and channel migration are limited. This is likely the combined result of a low gradient channel with base level control by Lake Huron (backwatering), and extensive artificial streambank armouring. Historical photos revealed that over 46 years (1970-2006), the channel has remained atypically stable in its planform configuration. Bank migration could only be accurately measured using air photos from one bend, occurring in two directions: laterally and downstream (**Figure 4**). This is a high valley contact comprised of erodible sands, where maximum rates of bank migration in each direction at this bend are 0.46m/year, with averages of 0.32 and 0.30m/year. The maximum rate over 100 years would be 46m of lateral migration. Woodland Drive ends in proximity to this meander, at a distance of 58m from the approximate bankfull channel: an acceptable distance beyond the 100-year erosion limit at this location.

Extensive bank armouring has created a relatively stable planform compared to that of more natural streams over the period of photo record: 1954-2006. This practice has resulted in a disconnected floodplain and degraded riparian habitat. Where structures have become undermined, or are in an unrepairable condition, there is an opportunity to replace these structures, and if possible, utilize a natural

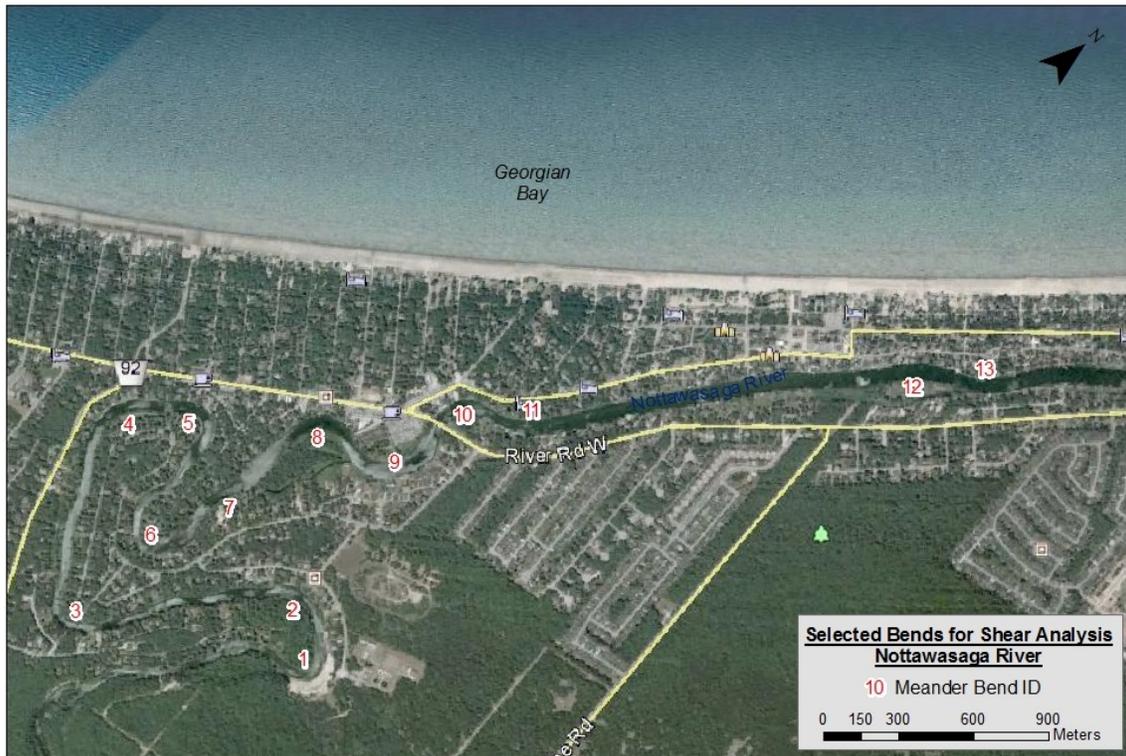
**Figure 6: Bend Locations for Shear Analysis.**

**Table 6: Bend Shear Results for Selected Bends**

Bend	Bend Shear (N/m <sup>2</sup> )
<b>Reach 1</b>	
1	23.90
2	20.15
<b>Reach 2</b>	
3	5.31
4	4.98
5	5.35
6	5.35
7	4.90
8	5.14
9	4.96
<b>Reach 3</b>	
10	3.59
11	3.37
12	2.95
13	2.97
<b>Min</b>	<b>2.95</b>
<b>Max</b>	<b>23.90</b>
<b>Mean</b>	<b>7.15</b>
<b>Mean</b>	<b>7.15</b>

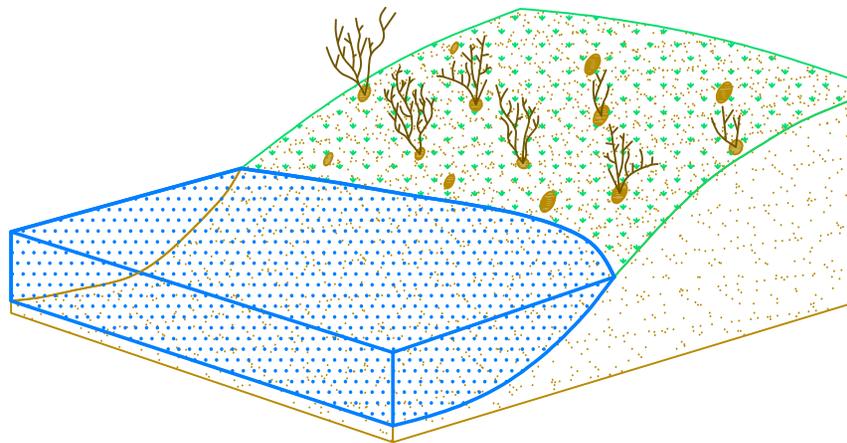
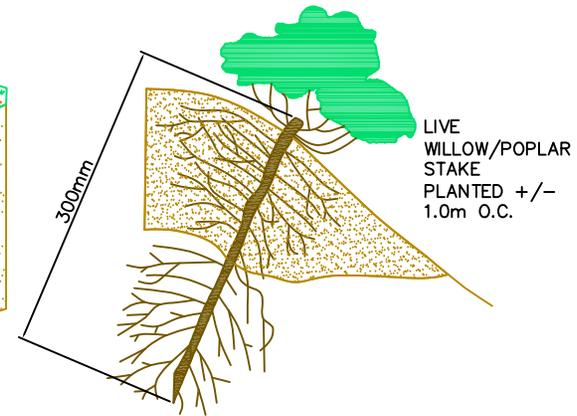
DRAWN: K.W.C.	SCALE: N.T.S.	<b>STD.DWG.No 1</b>
DESIGN: J.M. / E.G.	PLOT: 1=1	
CHECKED: R.D.S.	DATE: MAY 2014

1. BANKSLOPES GENTLER THAN 3:1 ARE REQUIRED
2. SUITABLE FOR LOCATIONS WITH LOW SHEAR STRESS (STRAIGHTER CHANNEL SECTIONS & DOWNSTREAM SIDE OF INNER MEANDER BANK)
3. BANKSLOPES FOR ADJACENT PROPERTIES 2:1 MAXIMUM, PREFERABLY GENTLER
4. LIVE/DORMANT STAKES OR POTTED PLANTS TO BE USED FOR PLANTING DEPENDING ON AVAILABILITY AND SEASON
5. NATIVE SEEDMIX SHOULD BE APPLIED TO ALL AREAS
6. GEOTEXTILE (COIR) SHOULD BE USED TO SECURE LOOSE MATERIAL DURING THE GERMINATION PERIOD AND WHILE PLANTINGS BECOME ESTABLISHED

**SHORELINE STABILIZATION STANDARD  
FOR NOTTAWASAGA RIVER  
NATURALIZE – SEED, STAKE/PLANT**

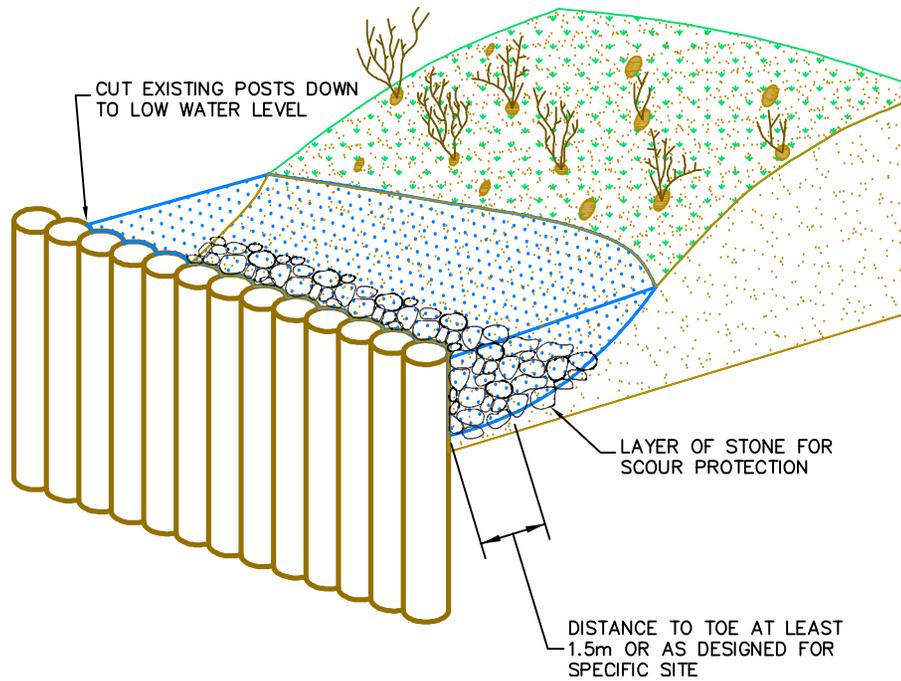
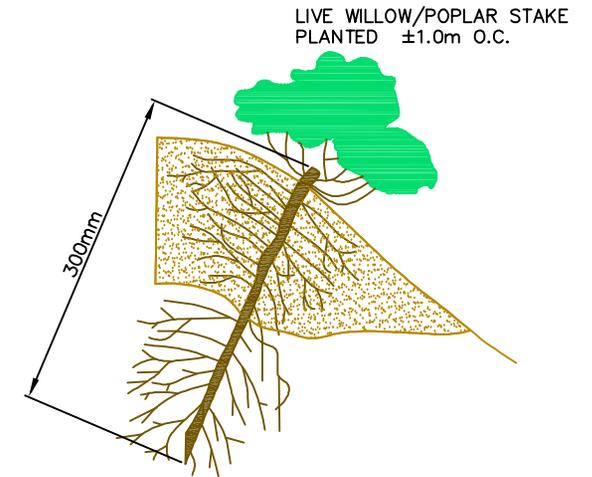
DRAWN: R.A.W.	SCALE: N.T.S.	STD.DWG.No 1A
DESIGN: J.M. / E.G.	PLOT: 1=1	
CHECKED: R.D.S.	DATE: DEC 2014

\* REPURPOSED CEDAR POST PROTECTION CAN BE COMBINED WITH ALL OF THE RECOMMENDED SHORELINE STABILIZATION MEASURES, PROVIDED THE RECOMMENDATIONS FOR POLE HEIGHT, STONE PROTECTION, AND TOE OF SLOPE SEPARATION SHOWN ON THIS PLAN ARE IMPLEMENTED.

1. BANKSLOPES GENTLER THAN 3:1 ARE REQUIRED.
2. SUITABLE FOR LOCATIONS WITH LOW SHEAR STRESS (STRAIGHTER CHANNEL SECTIONS & DOWNSTREAM SIDE OF INNER MEANDER BANK).
3. BANKSLOPES FOR ADJACENT PROPERTIES 2:1 MAXIMUM, PREFERABLY GENTLER.
4. LIVE/DORMANT STAKES OR POTTED PLANTS TO BE USED FOR PLANTING DEPENDING ON AVAILABILITY AND SEASON.
5. NATIVE SEEDMIX SHOULD BE APPLIED TO ALL AREAS.
6. GEOTEXTILE (COIR) SHOULD BE USED TO SECURE LOOSE MATERIAL DURING THE GERMINATION PERIOD AND WHILE PLANTINGS BECOME ESTABLISHED.

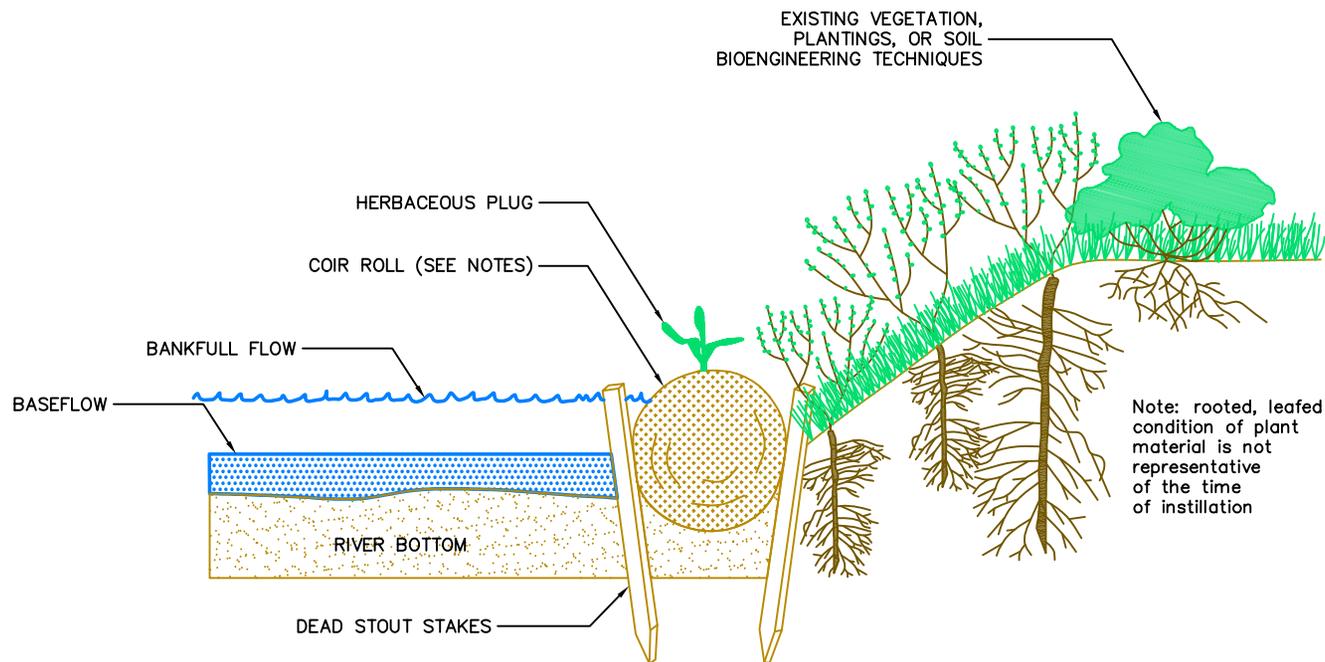
1. BANKSLOPES 2:1 OR GENTLER ARE REQUIRED
2. SUITABLE FOR LOCATIONS WITH HIGHER SHEAR STRESS
3. FOR BANKSLOPES OF 2:1, THIS IS AN OPTION WHEN ADJACENT PROPERTIES HAVE VERTICAL SHORELINES
4. THE COIR (COCONUT FIRBE) ROLL CAN BE REPLACED BY A ROCK TREATMENT IF EROSION IS OF PARTICULAR CONCERN
5. IN CASES WHERE THE SHORELINE EXTENDS HORIZONTALLY FOR 3 OR MORE METRES BEYOND THE TOE, THE COIR LOG CAN BE OFFSET AND EMERGENT AQUATIC VEGETATION PLANTED WITHIN THE SLACK WATER BOUND BY THE COIR LOG AND RIVER BANK< PROVIDING EXTRA STABILITY AND IN-CHANNEL AQUATIC HABITAT ENHANCEMENT
6. LIVE/DORMANT STAKES OR POTTED PLANTS TO BE USED FOR PLANTING DEPENDING ON AVAILABILITY AND SEASON
7. NATIVE SEEDMIX SHOULD BE APPLIED TO ALL AREAS

<b>TOWN OF WASAGA BEACH</b>		
<b>SHORELINE STABILIZATION STANDARD FOR NOTTAWASAGA RIVER BIOENGINEER-PLANT/STAKE, SEED, COIR LOG</b>		
DRAWN: K.W.C.	SCALE: N.T.S.	
DESIGN: J.M. / E.G.	PLOT: 1=1	
CHECKED: R.D.S.	DATE: MAY 2014	<b>STD.DWG.No. 2</b>

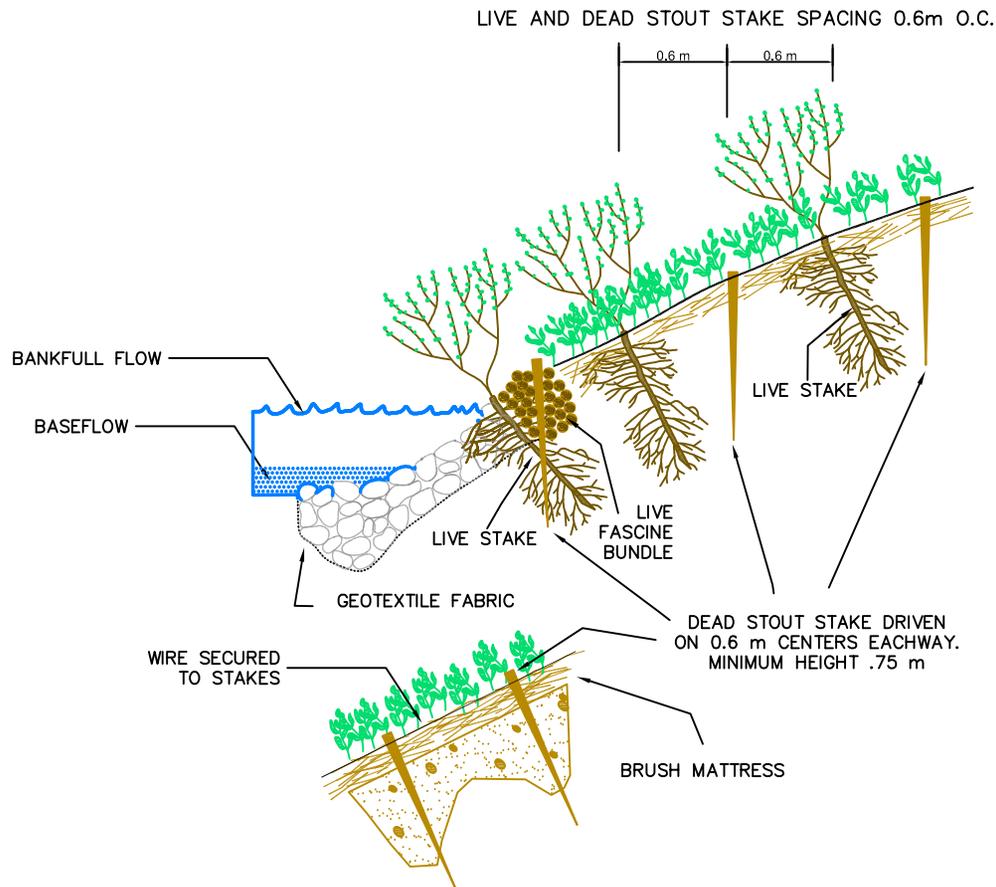
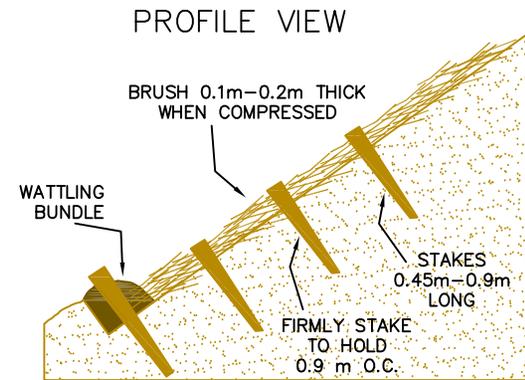
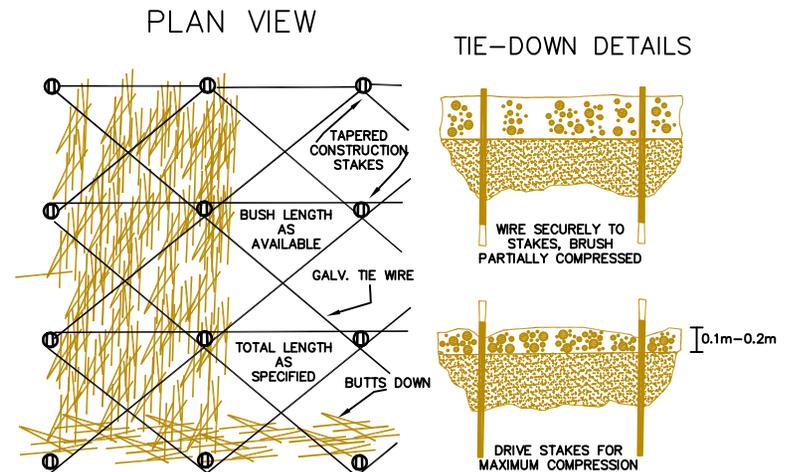
DRAWN: P.W.	SCALE: N.T.S.	STD.DWG.No 3
DESIGN: J.M. / E.G.	PLOT: 1=1	
CHECKED: R.D.S.	DATE: MAY 2014

1. BANKSLOPES BETWEEN 1.5:1 AND 2:1 OR GENTLER ARE REQUIRED
2. SUITABLE FOR LOCATIONS WITH HIGHER SHEAR STRESS INCLUDING OUTER BENDS OF MEANDERS
3. THE ROCK TREATMENT AT THE TOE OF SLOPE IS OPTIONAL. AND AN EXTRA FASCINE CAN BE UTILIZED ALTERNATIVELY IF DESIRED
4. WHEN A ROCK TREATMENT IS APPLIED, THE GEOTEXTILE CLOTH IS NOT RECOMMENDED AS IT CREATES A BARRIER WHICH REDUCES NECESSARY SETTLING AND PROMOTES SLIP.
5. THIS IS AN OPTION WHEN ADJACENT PROPERTIES HAVE VERTICAL SHORELINES
6. LIVE/DORMANT STAKES OR POTTED PLANTS TO BE USED FOR PLANTING DEPENDING ON AVAILABILITY AND SEASON
7. NATIVE SEEDMIX SHOULD BE APPLIED TO ALL AREAS

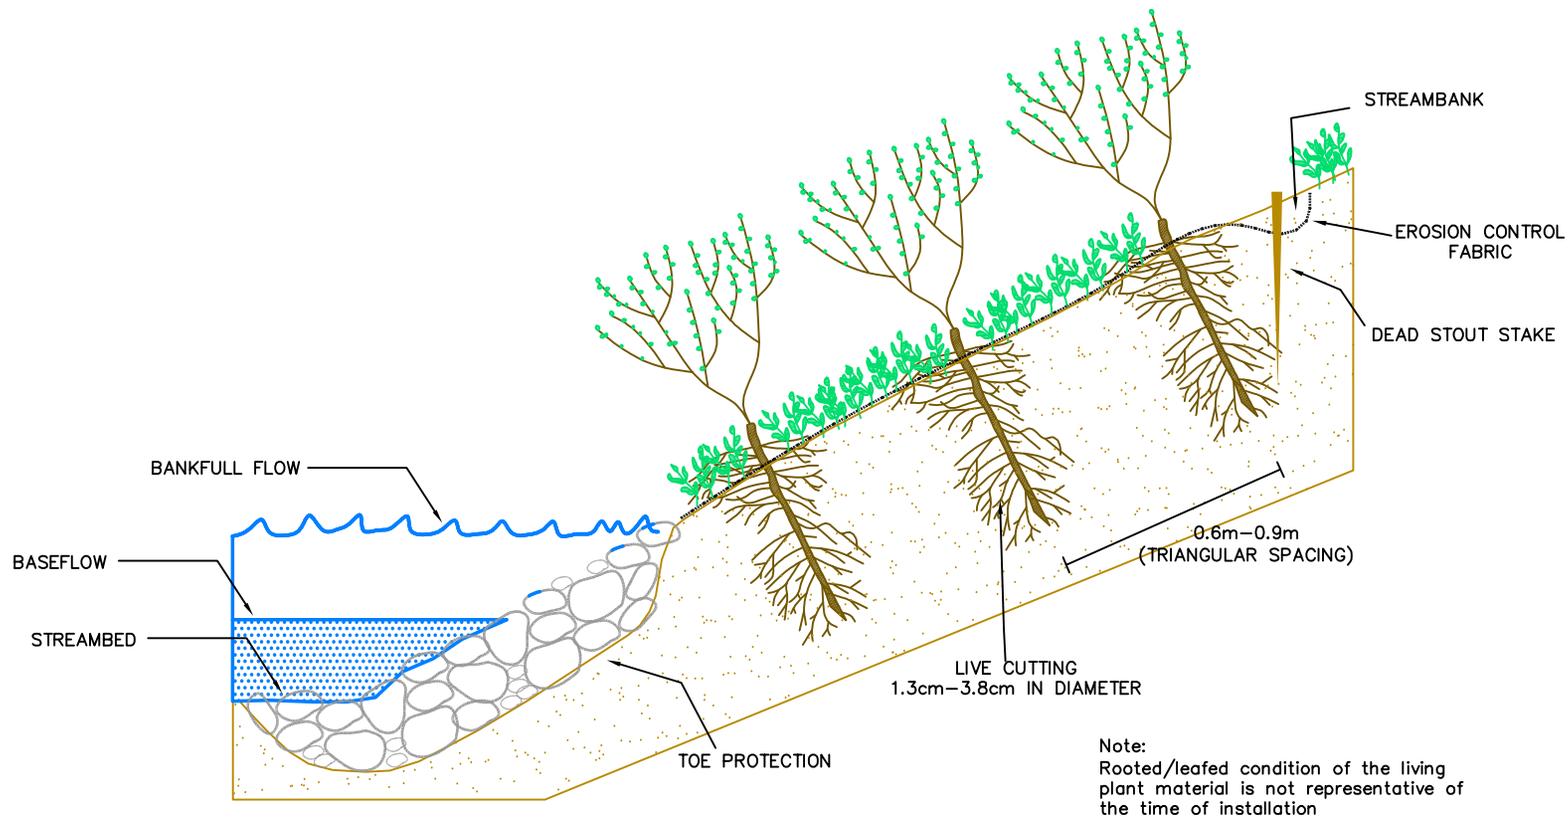
1. BANKSLOPES BETWEEN 1.5:1 AND 2:1 OR GREATER CAN BE USED.
2. SUITABLE FOR LOCATIONS WITH HIGHER SHEAR STRESS INCLUDING OUTER BENDS OF MEANDERS
3. ROCK PROTECTION AT THE TOE OF SLOPE SHOULD BE SIZED TO REMAIN STABLE. IF NECESSARY USE LARGE, ANGULAR BOULDER ALONG THE TOE OF SLOPE TO OBTAIN THE NEEDED STABILITY.
4. BANK SLOPES CAN BE COMPLEX WITH A STEEPER SLOPE FOR THE ROCKY-TOE PORTION, AND GENTLER AS THE GRADE MEETS THE TOP OF BANK. AN EXAMPLE OF THIS WOULD BE USING A 1.5:1 SLOPE ALONG THE TOE, WITH A 2:1 SLOPE BEHIND IT THAT IS PLATED AND SEEDED.
5. THE PLANTED/SEEDED SLOPE SHOULD BE SECURED WITH A GEOTEXTILE LIKE COIR CLOTH.

<b>TOWN OF WASAGA BEACH</b>		
<b>SHORELINE STABILIZATION STANDARD FOR NOTTAWASAGA RIVER BIOENGINEER-TOE ARMOURING AND PLANTING</b>		
DRAWN: P.W.	SCALE: N.T.S.	
DESIGN: J.M. / E.G.	PLOT: 1=1	
CHECKED: R.D.S.	DATE: MAY 2014	<b>STD.DWG.No. 4</b>

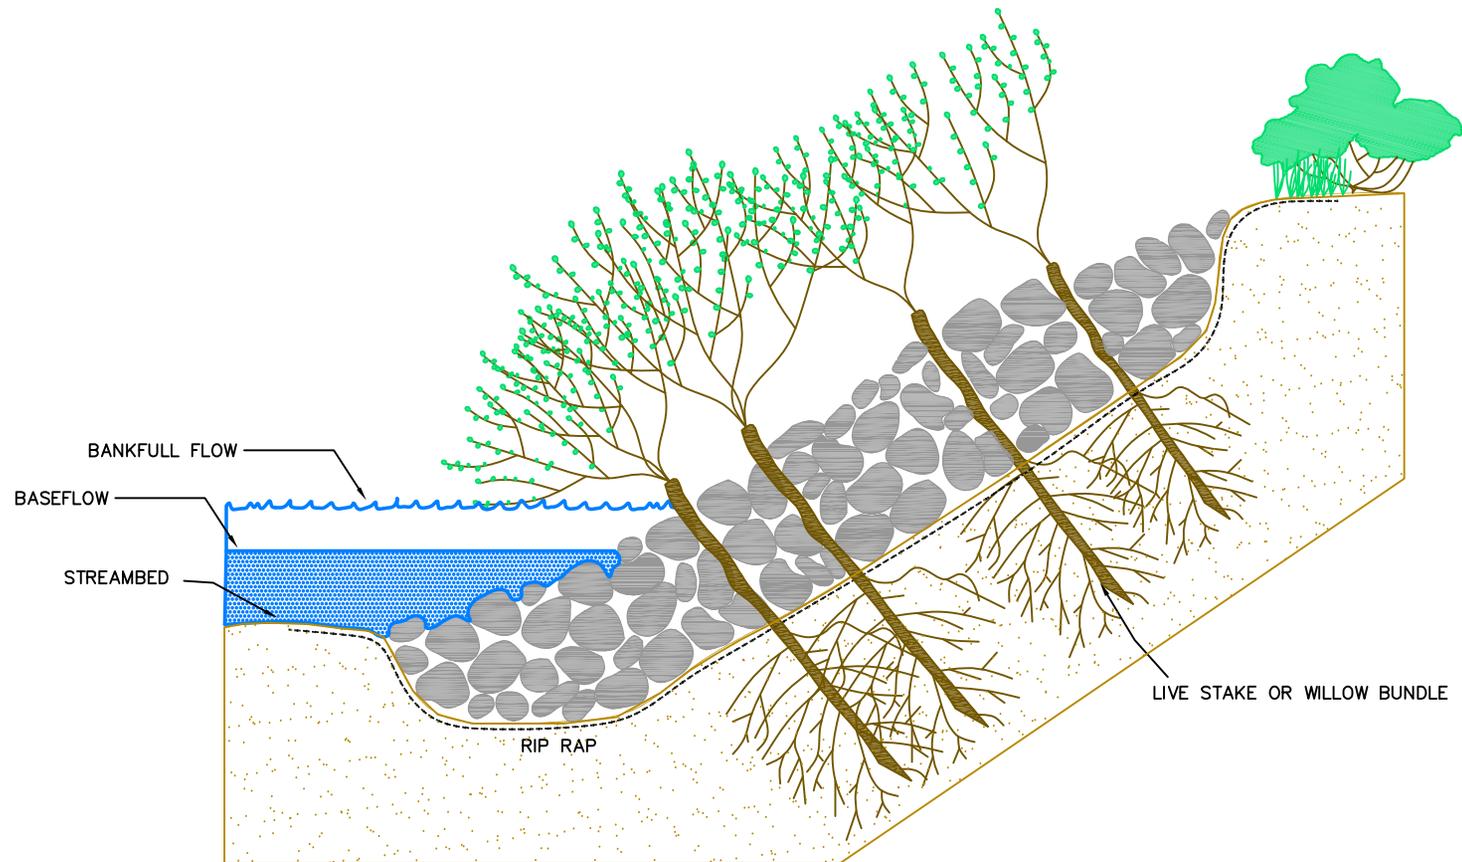
DRAWN: K.W.C.	SCALE: N.T.S.	<b>STD.DWG.No. 5</b>
DESIGN: J.M. / E.G.	PLOT: 1=1	
CHECKED: R.D.S.	DATE: MAY 2014

1. BANK SLOPES CAN VARY FROM 1.5:1 TO 3:1
2. FOR 1.5:1 and 2:1 SLOPES THIS IS AN OPTION WHEN ADJACENT PROPERTIES HAVE VERTICAL SHORELINES
3. VEGETATED RIP RAP CAN BE USED ALONG ZONES OF ACTIVE EROSION SUCH AS OUTER BENDS AS A MEASURE OF STABILITY, WHILE PROVIDING SOME HABITAT BENEFIT THROUGH THE USE OF A GRADED DISTRIBUTION OF ROCK AND SOME OVERHANGING VEGETATION
4. WLIVE/DORMANT STAKES OR POTTED PLANTS TO BE USED FOR PLANTING DEPENDING ON AVAILABILITY AND SEASON
5. NATIVE SEEDMIX SHOULD BE APPLIED TO ALL AREAS

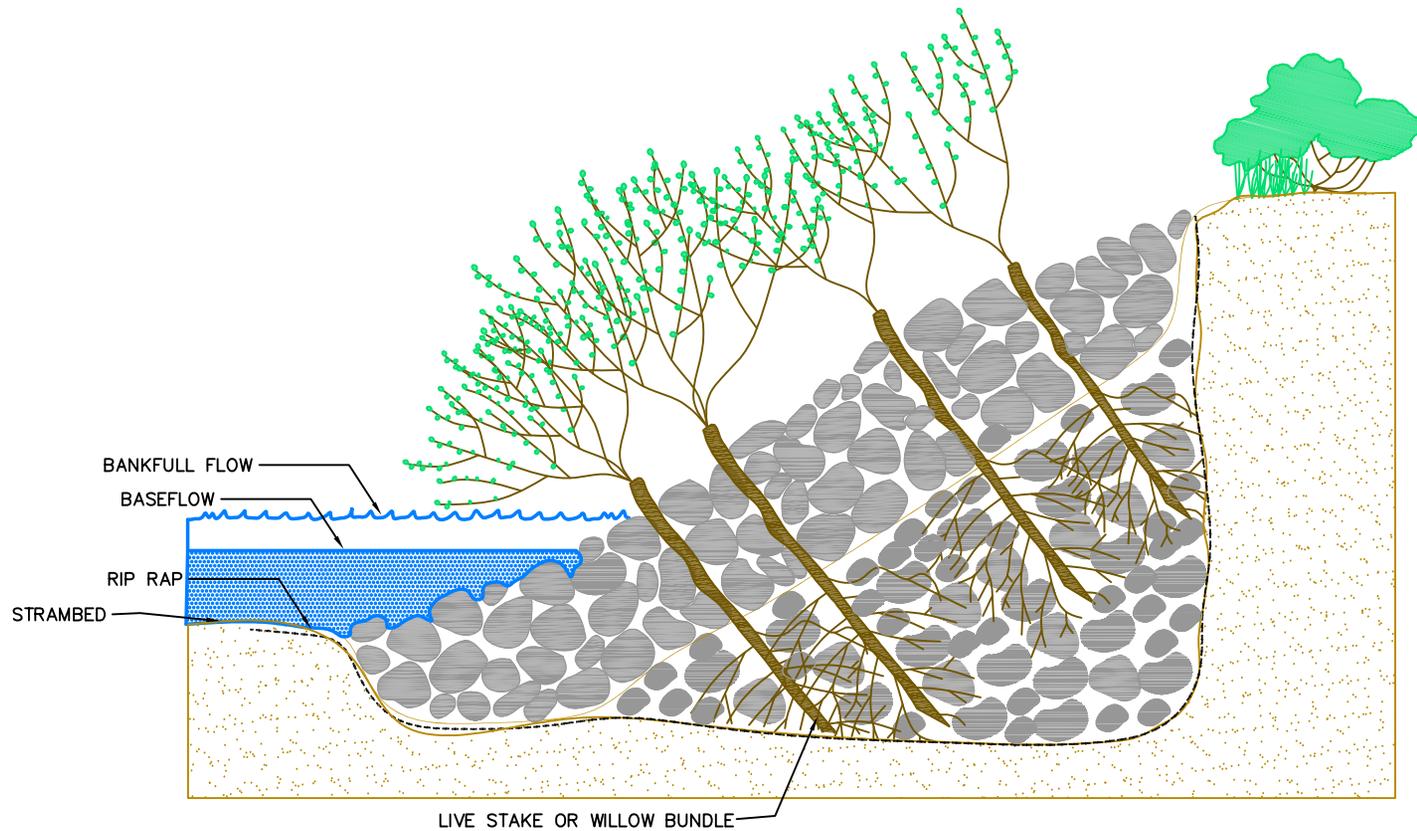
DRAWN: P.W.	SCALE: N.T.S.	
DESIGN: J.M. / E.G.	PLOT: 1=1	
CHECKED: R.D.S.	DATE: MAY 2014	<b>STD.DWG.No. 6</b>

1. BANK SLOPES CAN VARY FROM 1.5:1 TO 3:1
2. FOR 1.5:1 and 2:1 SLOPES THIS IS AN OPTION WHEN ADJACENT PROPERTIES HAVE VERTICAL SHORELINES
3. THE BUTTRESS DESIGN CREATES A GREATER THICKNESS, AND THE STRUCTURE HAS THE ABILITY TO SUPPORT ITSELF RATHER THAN RELY ON THE UNDERLYING BANK FOR SUPPORT
4. W/LIVE/DORMANT STAKES OR POTTED PLANTS TO BE USED FOR PLANTING DEPENDING ON AVAILABILITY AND SEASON
5. NATIVE SEEDMIX SHOULD BE APPLIED TO ALL AREAS

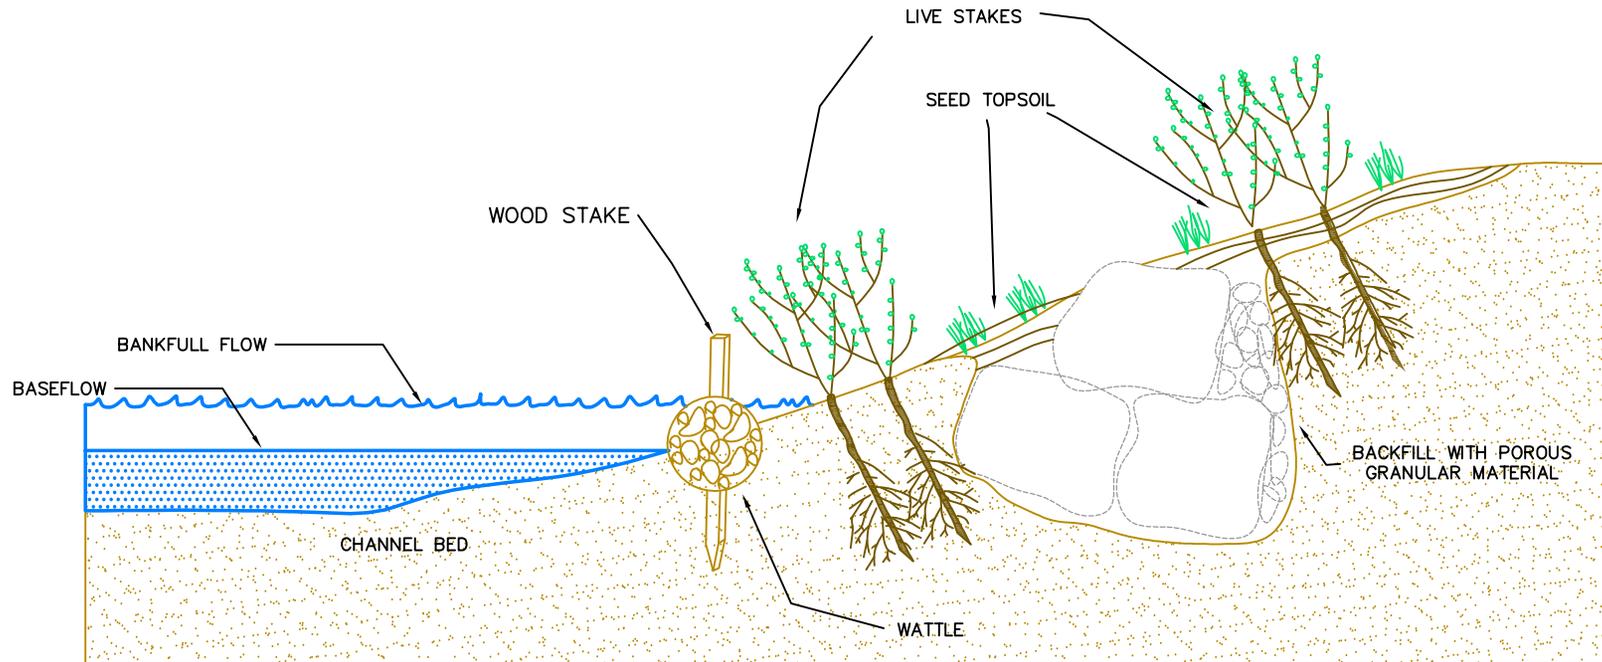
DRAWN: P.W.	SCALE: N.T.S.	STD.DWG.No. 7
DESIGN: J.M. / E.G.	PLOT: 1=1	
CHECKED: R.D.S.	DATE: MAY 2014

1. BANKSLOPES SHOULD BE BETWEEN 2:1 AND 3:1
2. LIVE/DORMANT STAKES OR POTTED PLANTS TO BE USED FOR PLANTING DEPENDING ON AVAILABILITY AND SEASON
3. ADJACENT PROPERTIES SHOULD HAVE SIMILAR SLOPES IN ORDER TO TRANSITION INTO EASILY.
4. NATIVE SEEDMIX SHOULD BE APPLIED TO ALL AREAS

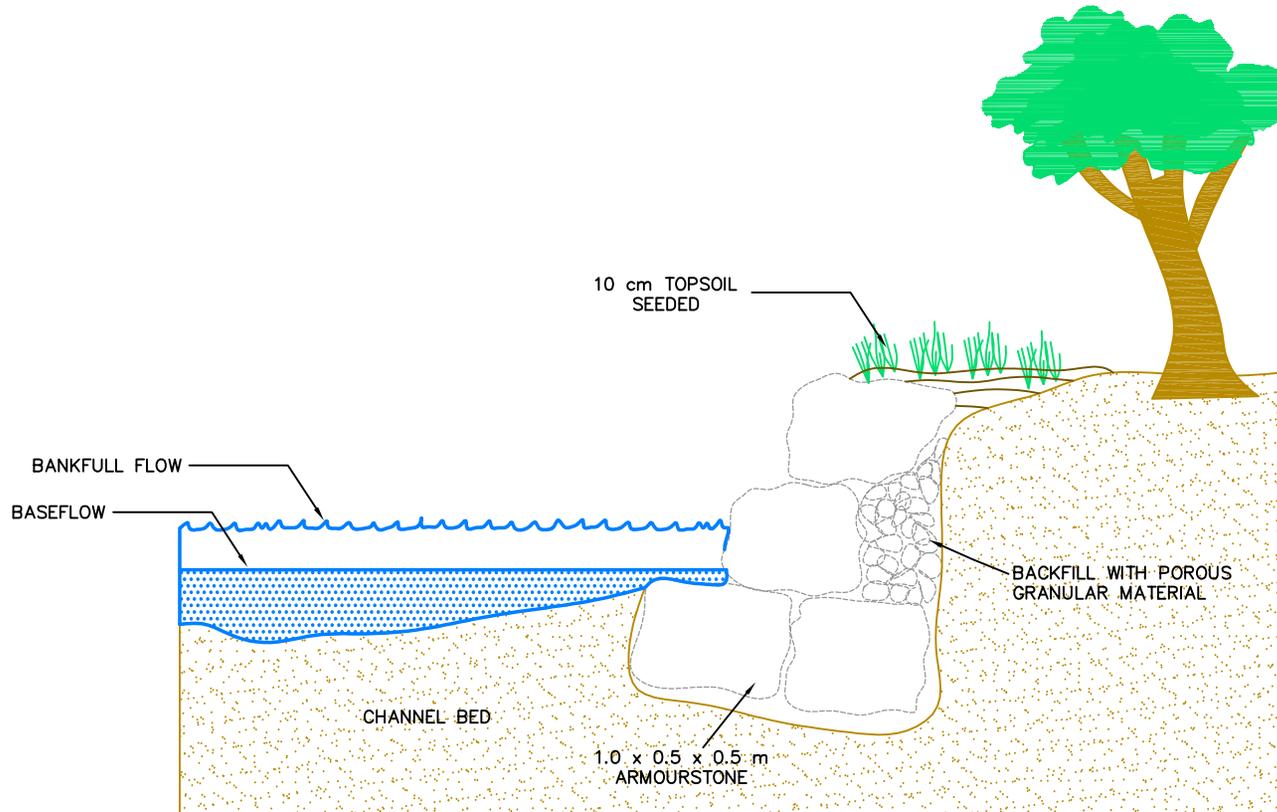
DRAWN: P.W.	SCALE: N.T.S.	<b>STD.DWG.No. 8</b>
DESIGN: J.M. / E.G.	PLOT: 1=1	
CHECKED: R.D.S.	DATE: MAY 2014

1. WHERE SETBACKS FROM EXISTING EDGE OF THE CHANNEL ARE NOT SUFFICIENT ENOUGH TO RE-GRADE THE BANK TO A GENTLER SLOPE THIS OPTION CAN BE CONSIDERED. GENERALLY USED WHEN BANKSLOPES ARE BETWEEN 0.5:1 AND 1:1.
2. THIS ARRANGEMENT IS UTILIZED AS A MORE "NATURAL" OPTION AS OPPOSED TO SHEET-PILING.
3. CONSTRUCTING THIS WOULD REQUIRE GUIDANCE FROM A GEOTECHNICAL AND STRUCTURAL ENGINEER TO INSURE PROPER SLOPE STABILITY AND SHEAR CAPACITY IS OBTAINED.

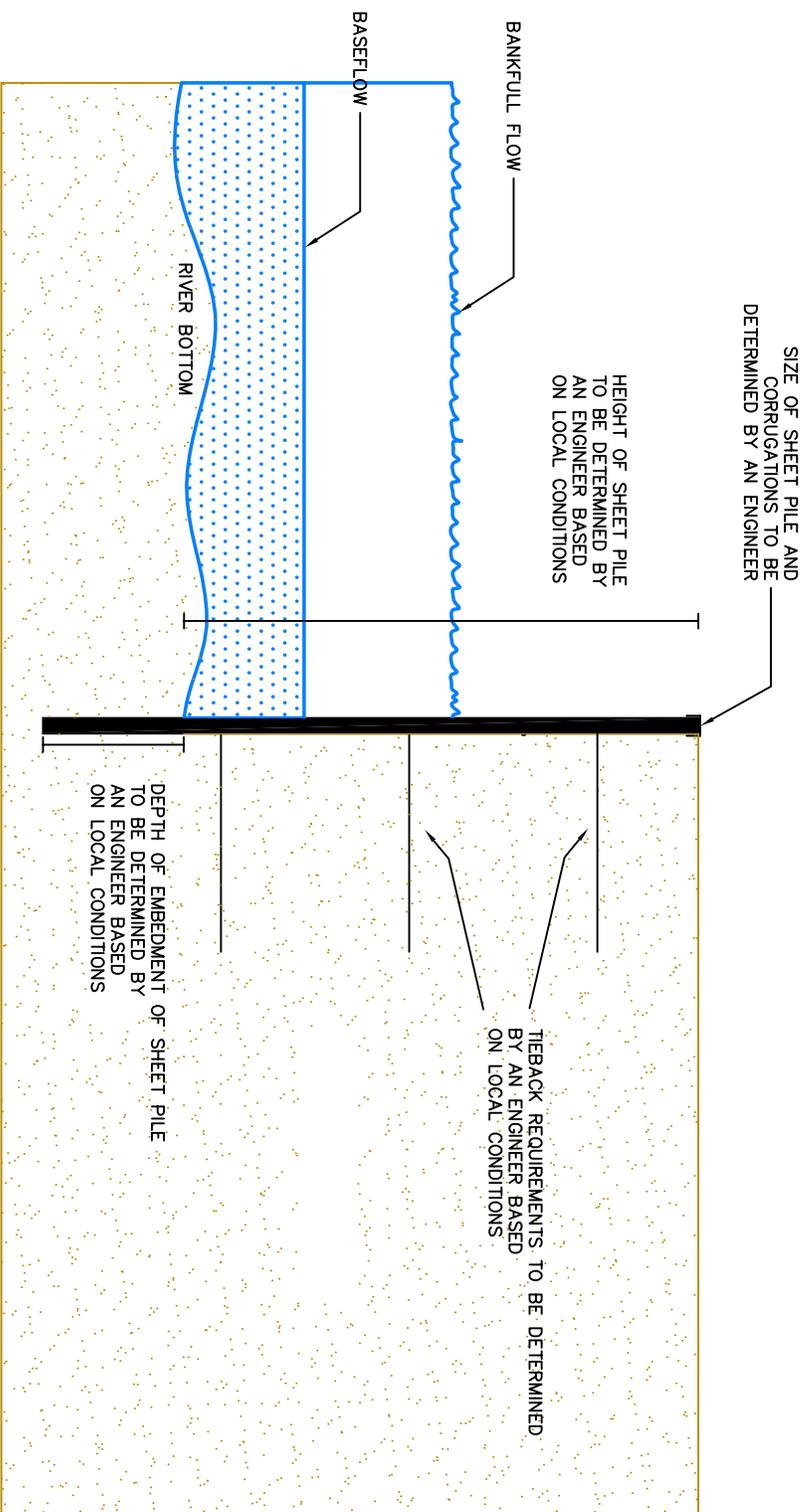
- NOTES**
1. SHEET PILES ARE RECOMMENDED WHERE SETBACKS ARE TOO GREAT TO ALLOW FOR ANY OF THE PREVIOUS OPTIONS
  2. CONSTRUCTION OF SHEET PILE RETAINING WALLS WILL REQUIRE DESIGN BY A GEOTECHNICAL AND/OR STRUCTURAL ENGINEER TO ENSURE STABILITY AND STRENGTH OF WALL.

**TOWN OF WASAGA BEACH**  
**SHORELINE STABILIZATION STANDARD**  
**FOR NOTTAWASAGA RIVER**  
**SHEET PILE**

DRAWN: P.W.	SCALE: N.T.S.	
DESIGN: J.M. / E.G.	PLOT: 1=1	
CHECKED: R.D.S.	DATE: MAY 2014	<b>STD.DWG.No. 9</b>

Sheet piles will likely be needed for sections of the river where there are existing vertical shorelines and there is no room to regrade the bank due to a small setback between the top of bank and a building structure, or driveway, or other significant property features. This option is recommended where when naturalization or armourstone retaining walls are not a viable option.

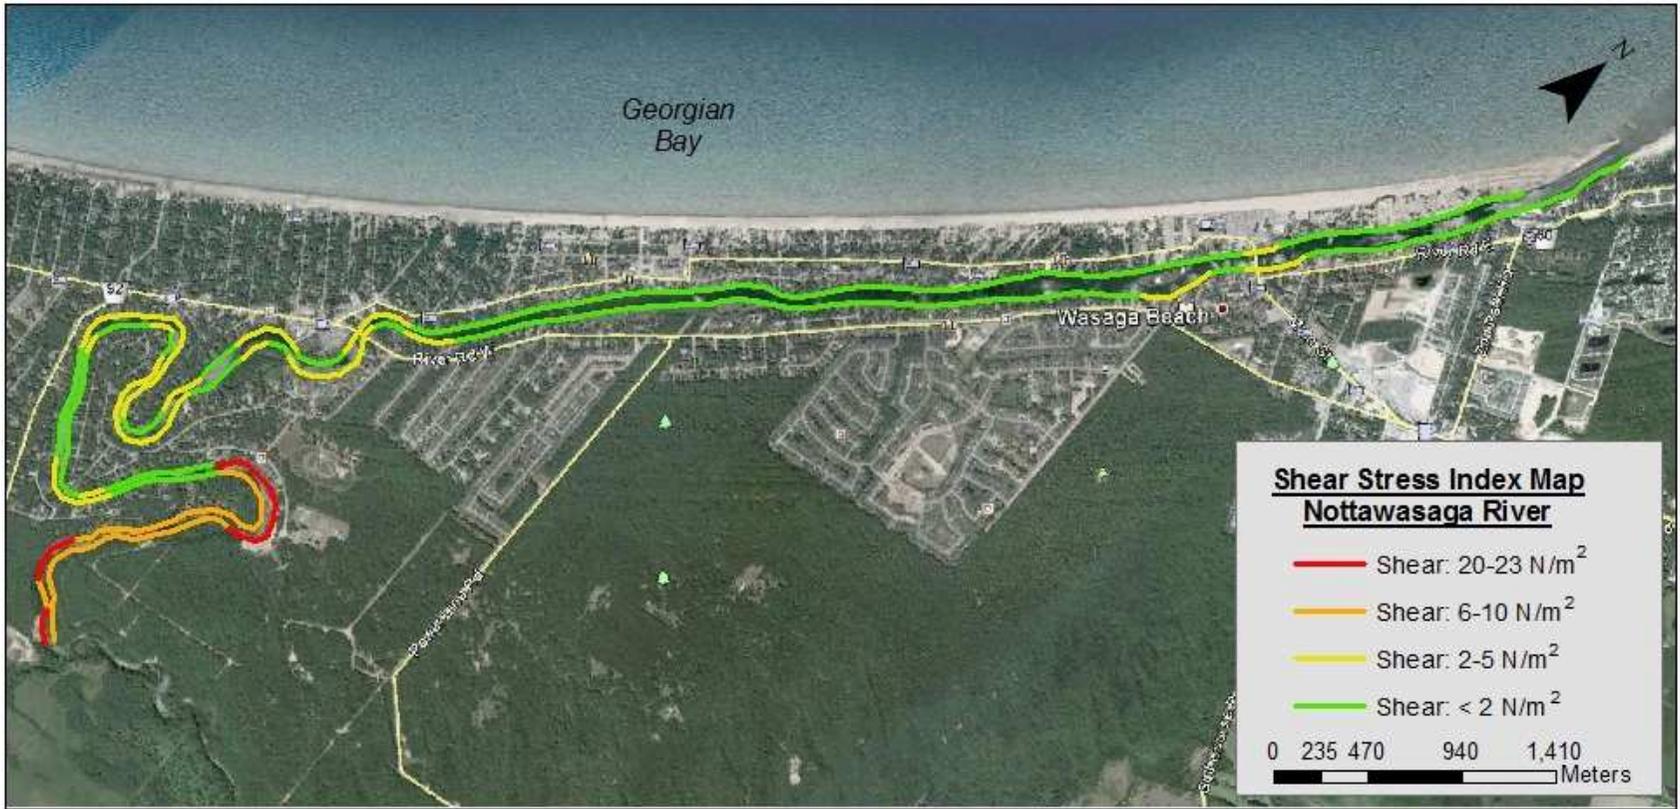
Figure: Index map showing shear condition along banks.

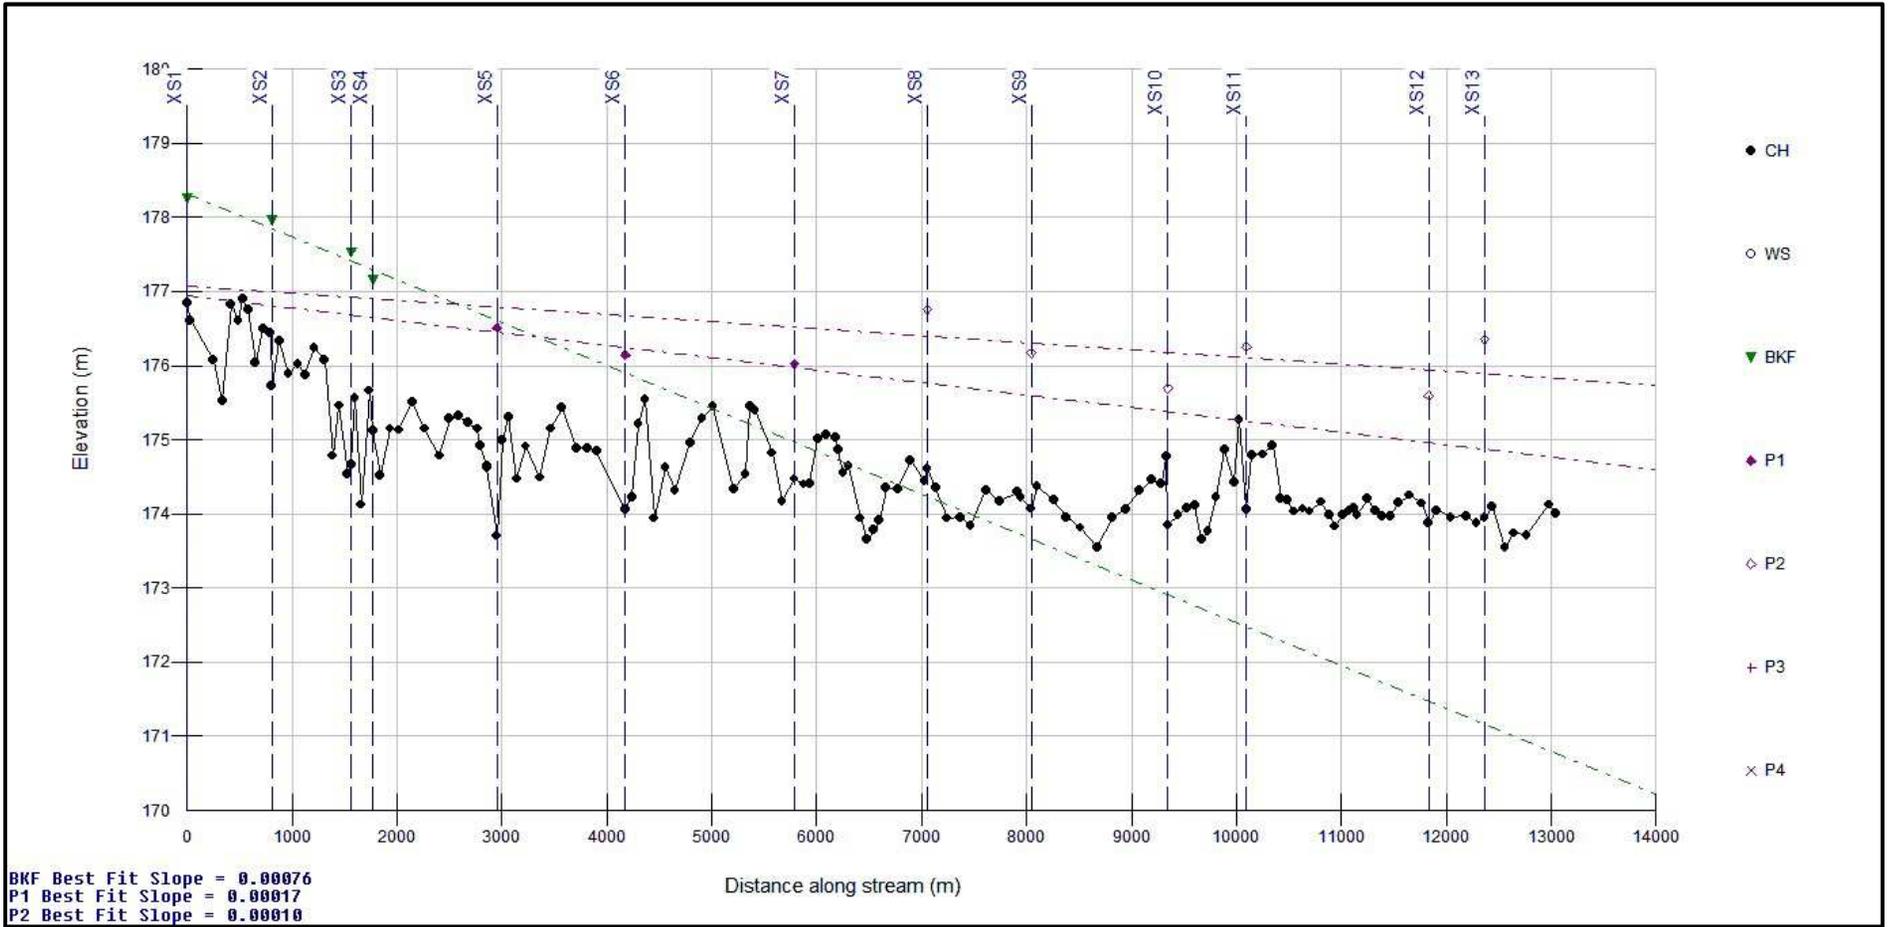
Figure 1: Longitudinal Profile

Figures showing the longitudinal profiles and cross sections of the river are provided in Appendix B. Appendix D shows photographs detailing typical channel conditions within the study area.

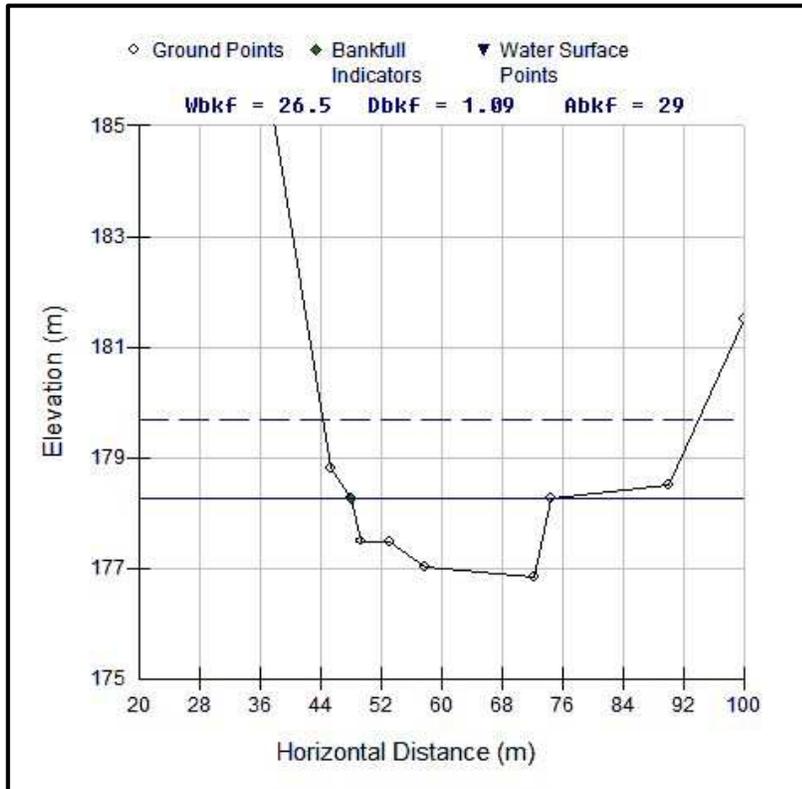
Figure 2: Cross Section 1

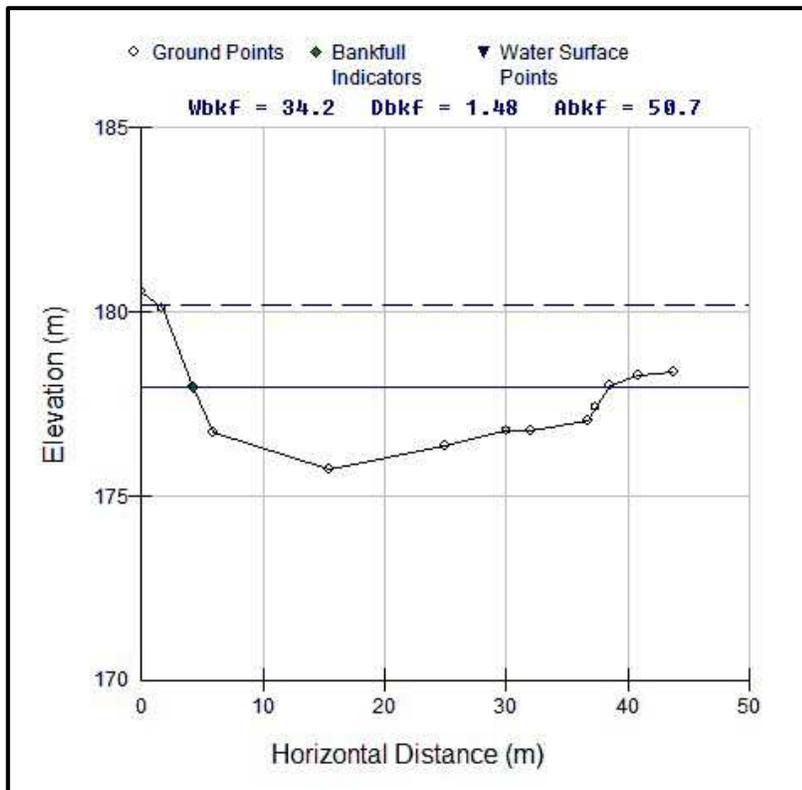
Figure 3: Cross Section 2

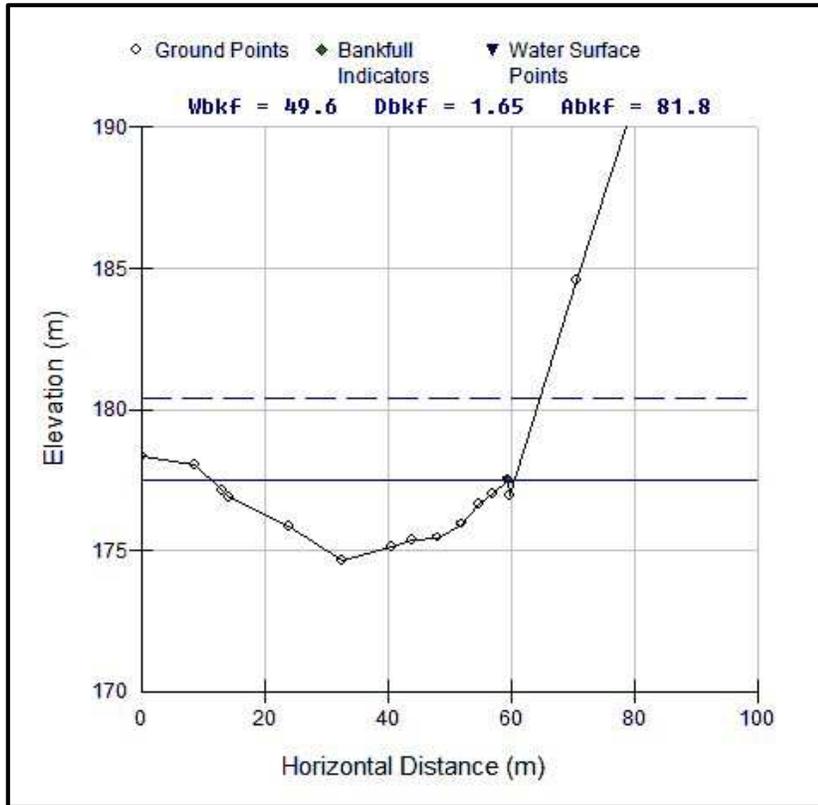
Figure 4: Cross Section 3

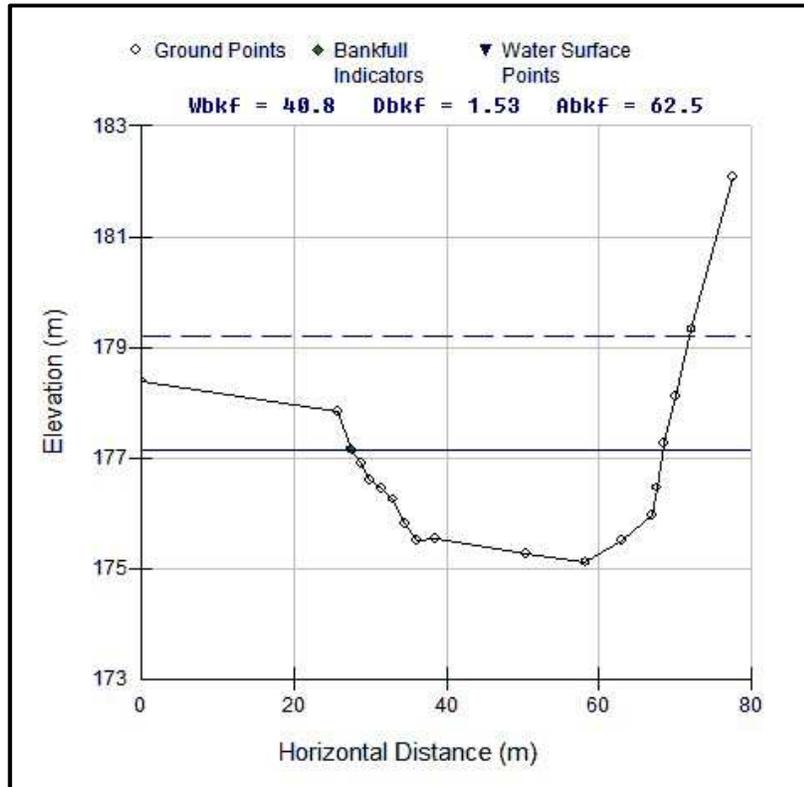
Figure 5: Cross Section 4

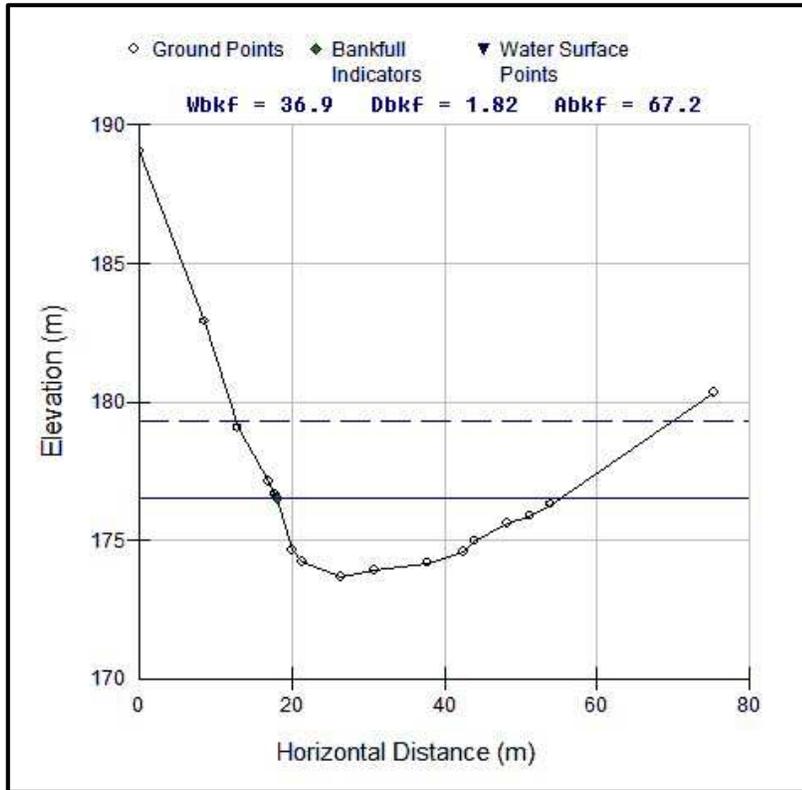
Figure 6: Cross Section 5

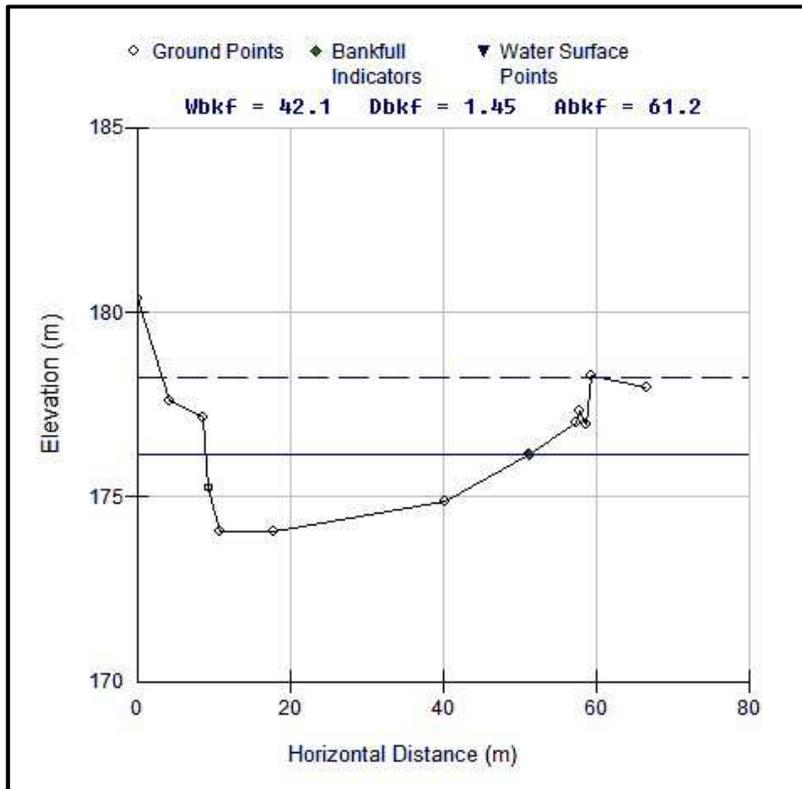
Figure 7: Cross Section 6

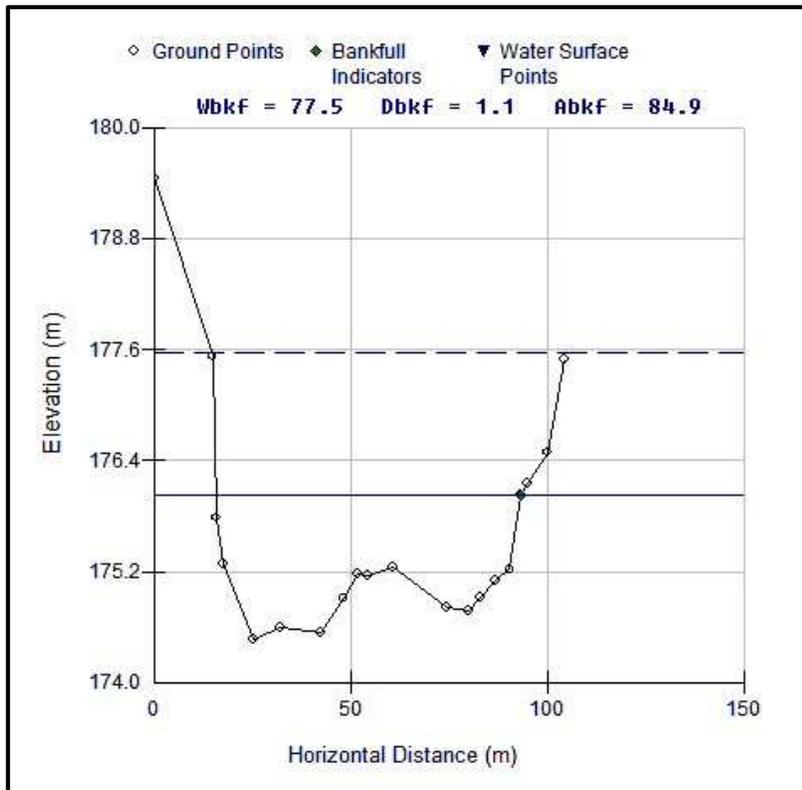
Figure 8: Cross Section 7
