# **NOTTAWASAGA RIVER SHOREWALL STANDARDS**

**December 2014**

**Prepared for  
THE TOWN OF WASAGA BEACH**

**NOTTAWASAGA RIVER  
SHOREWALL STANDARDS**

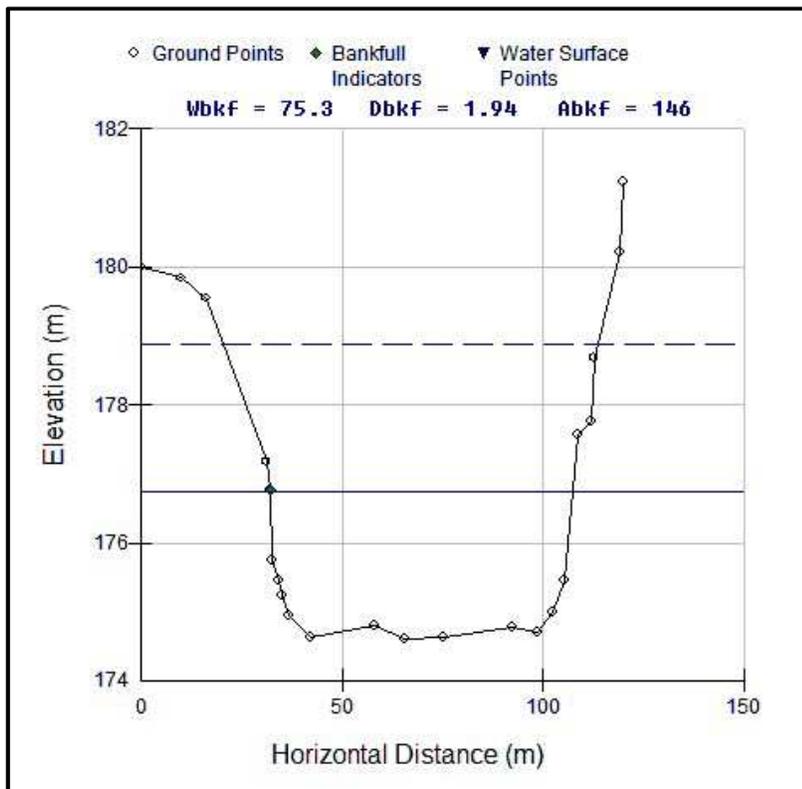
Figure 9: Cross Section 8

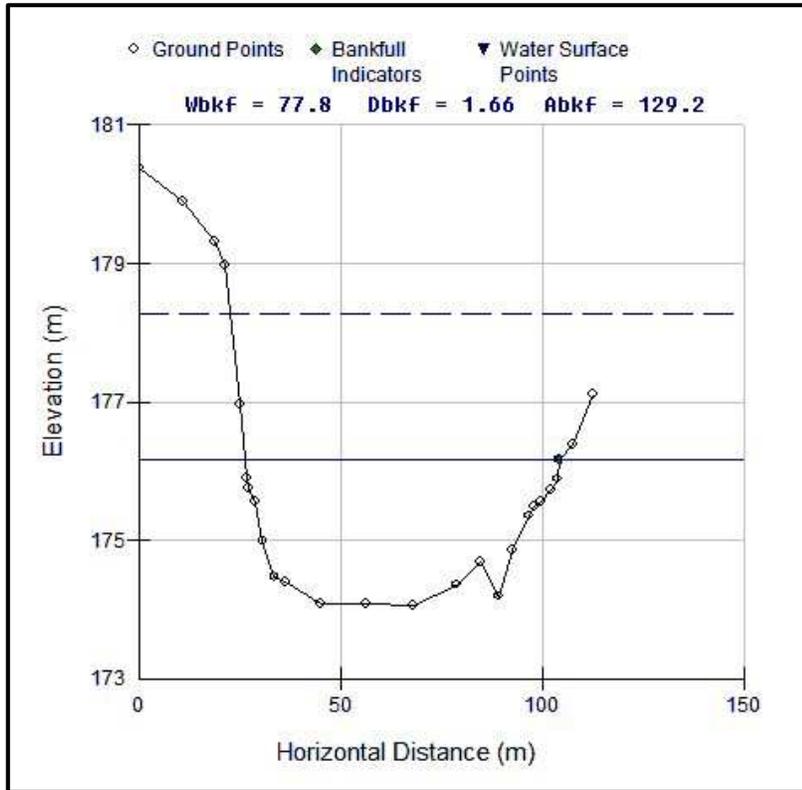
Figure 10: Cross Section 9

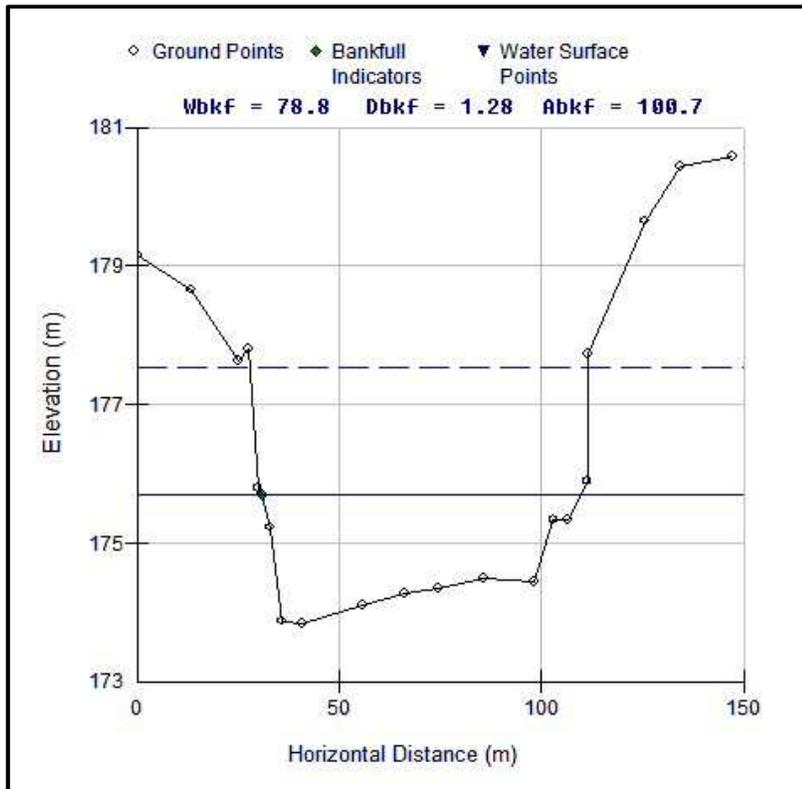
Figure 11: Cross Section 10

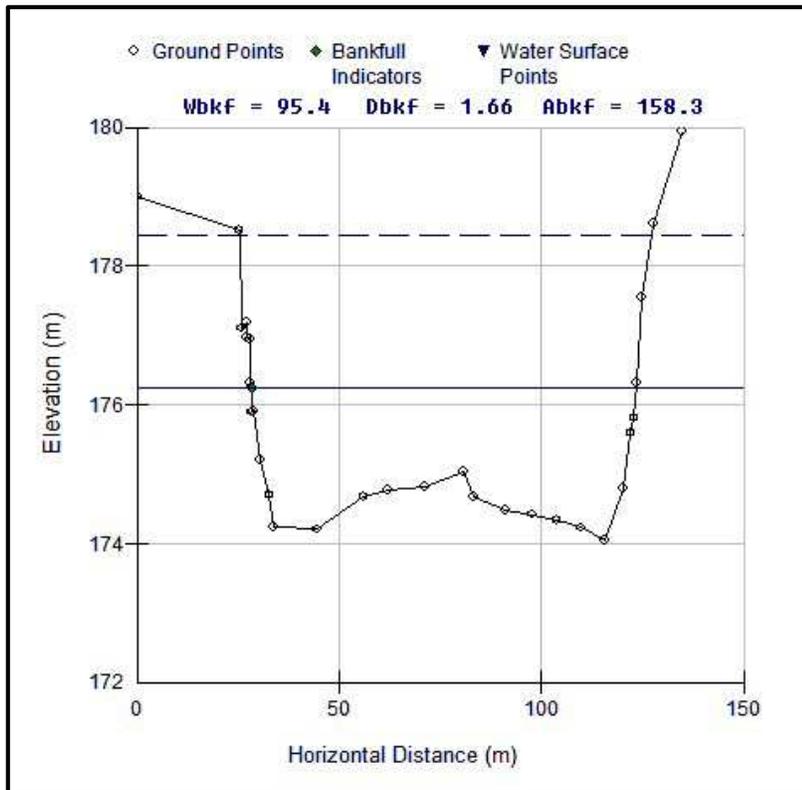
Figure 12: Cross Section 11

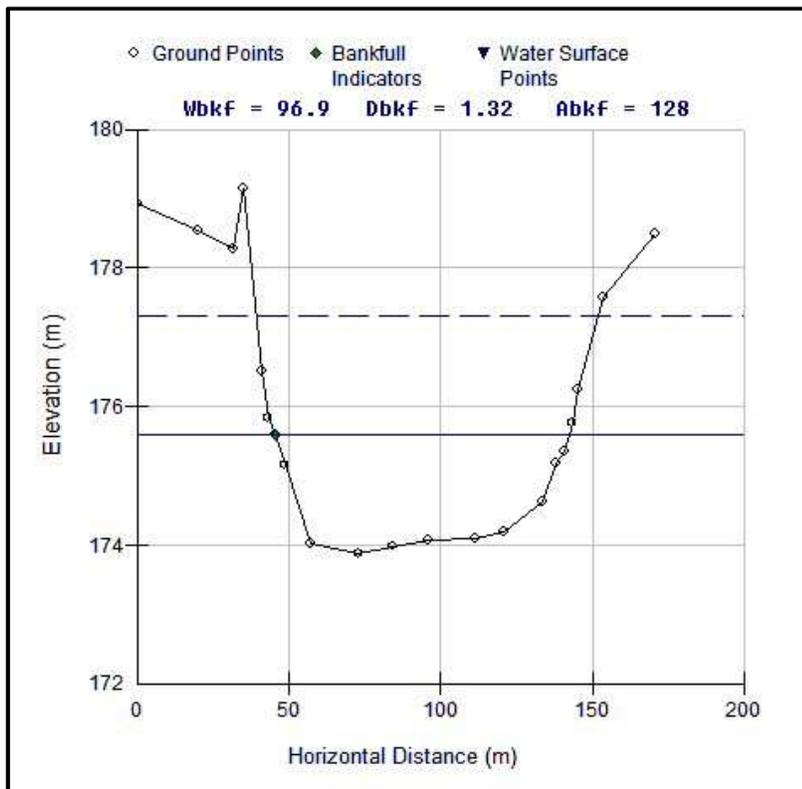
Figure 13: Cross Section 12

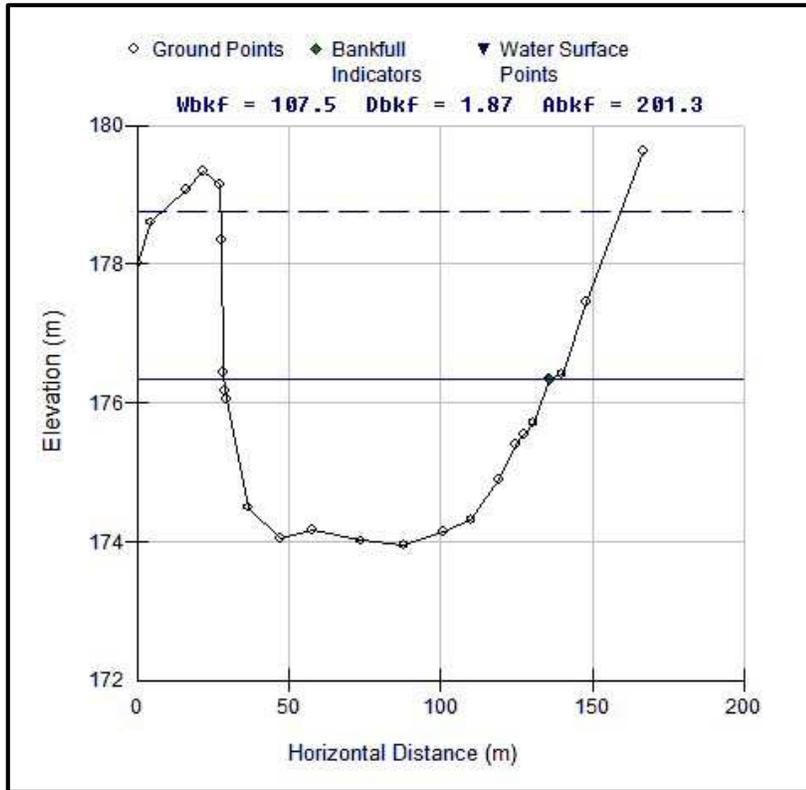
Figure 14: Cross Section 13
