**Functional Servicing and Stormwater  
Management Report  
Proposed 10 Lot Residential  
Development  
Golf Course Road**

**TPC Marlwood Inc.  
31 Marlwood Avenue  
Wasaga Beach ON L9Z 1S8**

**R.J. Burnside & Associates Limited  
3 Ronell Crescent  
Collingwood ON L9Y 4J6 CANADA**

**July 6, 2017  
300039210.0000**

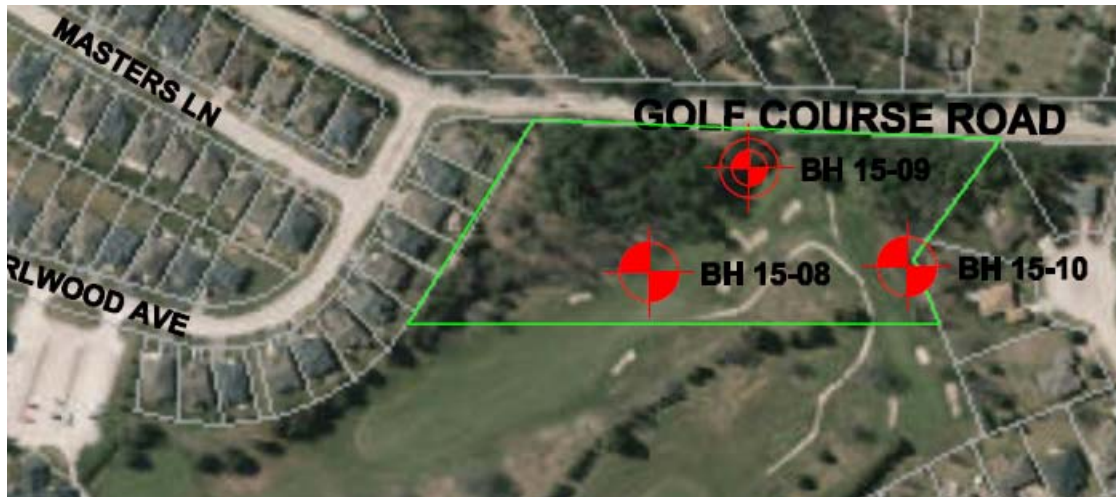
**Image 1      Borehole Locations**

A Preliminary Geotechnical Investigation was undertaken by SPL/WSP, dated November 2015. Refer to Appendix E for enclosure of the full Report. Boreholes and a groundwater monitoring well were completed at the following locations. Refer to image below. This report will be updated shortly to Final and submitted to the Town for review.

Generally, boreholes sampled on site (BH 15-08 to BH 15-10) revealed the soils to be sand with a layer of marl at varying depths, with a layer of topsoil ranging from 5 to 15 cm in depth. The marl was generally shallow enough for footings to extend below the bottom of the marl layer. Infiltration practices will also be effective if extended below the marl layer.

Groundwater was observed in Borehole 15-09 at a depth of 4.9 mbg in September 2015. A seasonal high level reading was taken in April of 2016 at 4.38 mbg, and the Summary Table is included in Appendix E.

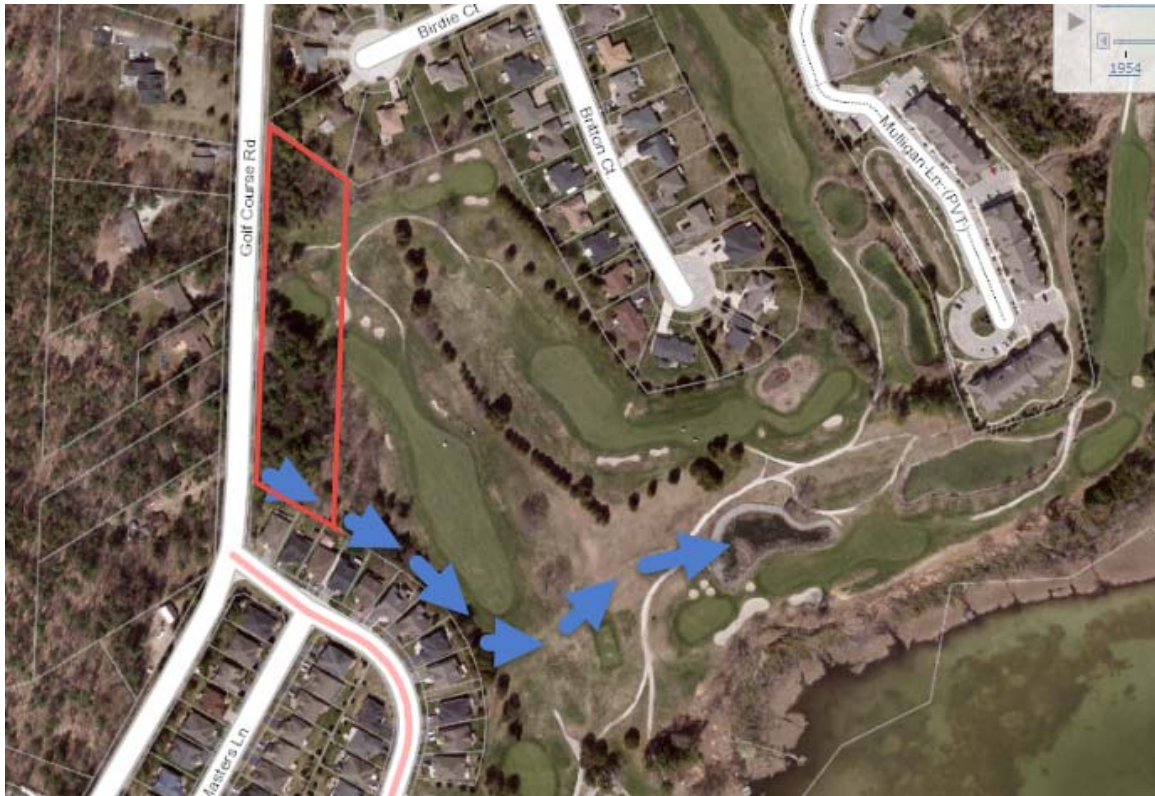
**Image 2 Emergency Overland Flow Route**

The proposed development will be graded to ensure that the impact of the development will not adversely affect adjacent private property, and that drainage will be directed to stormwater management system(s). An emergency overland flow route will direct runoff through the Golf Course via the public easement to an existing Golf Course SWM pond adjacent to the Marl Lake, as illustrated below.

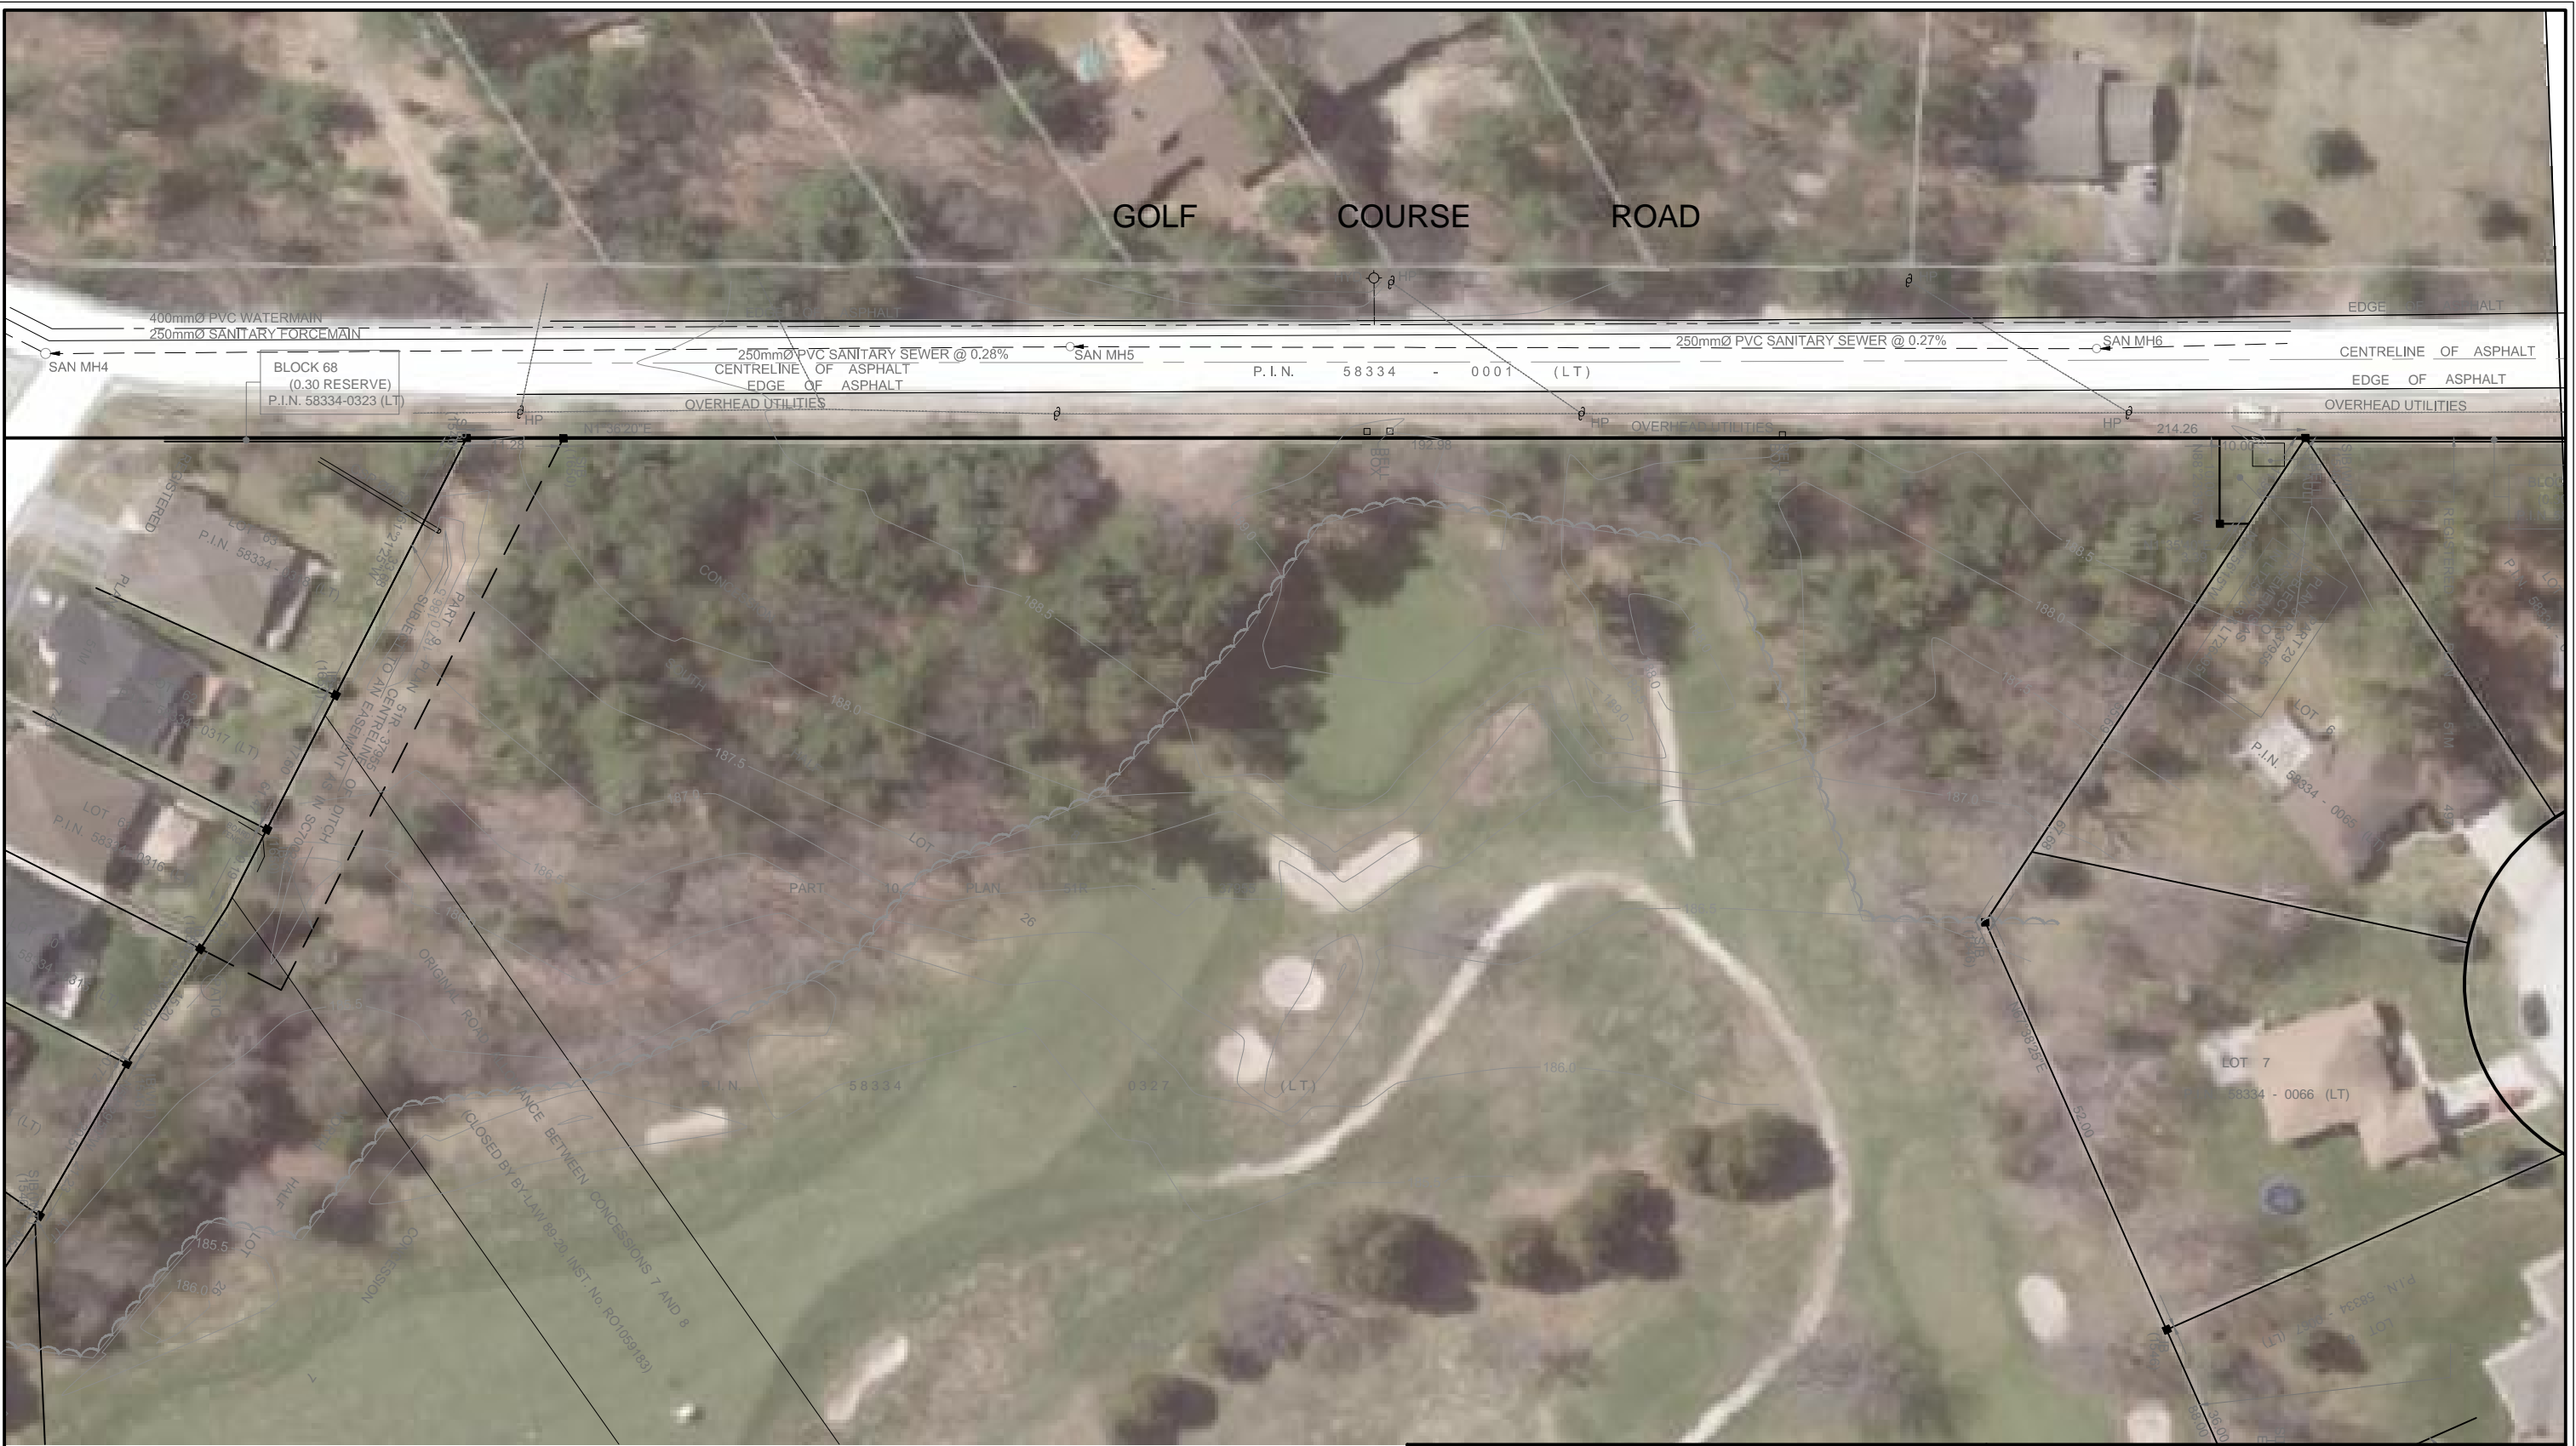
Figure Title			
<b>MARLWOOD (10 LOTS)</b>			
EXISTING CONDITIONS			
Client	Drawn	Checked	Date
<b>TPC MARLWOOD INC.</b>	KAG	EDT	17/04/21
	Scale	Project No.	
	1:750	300039210	
			Figure No.
			<b>3</b>

BLOCK 68  
(0.30 RESERVE)  
P.I.N. 58334-0323 (LT)

P.I.N. 58334 - 0001 (LT)

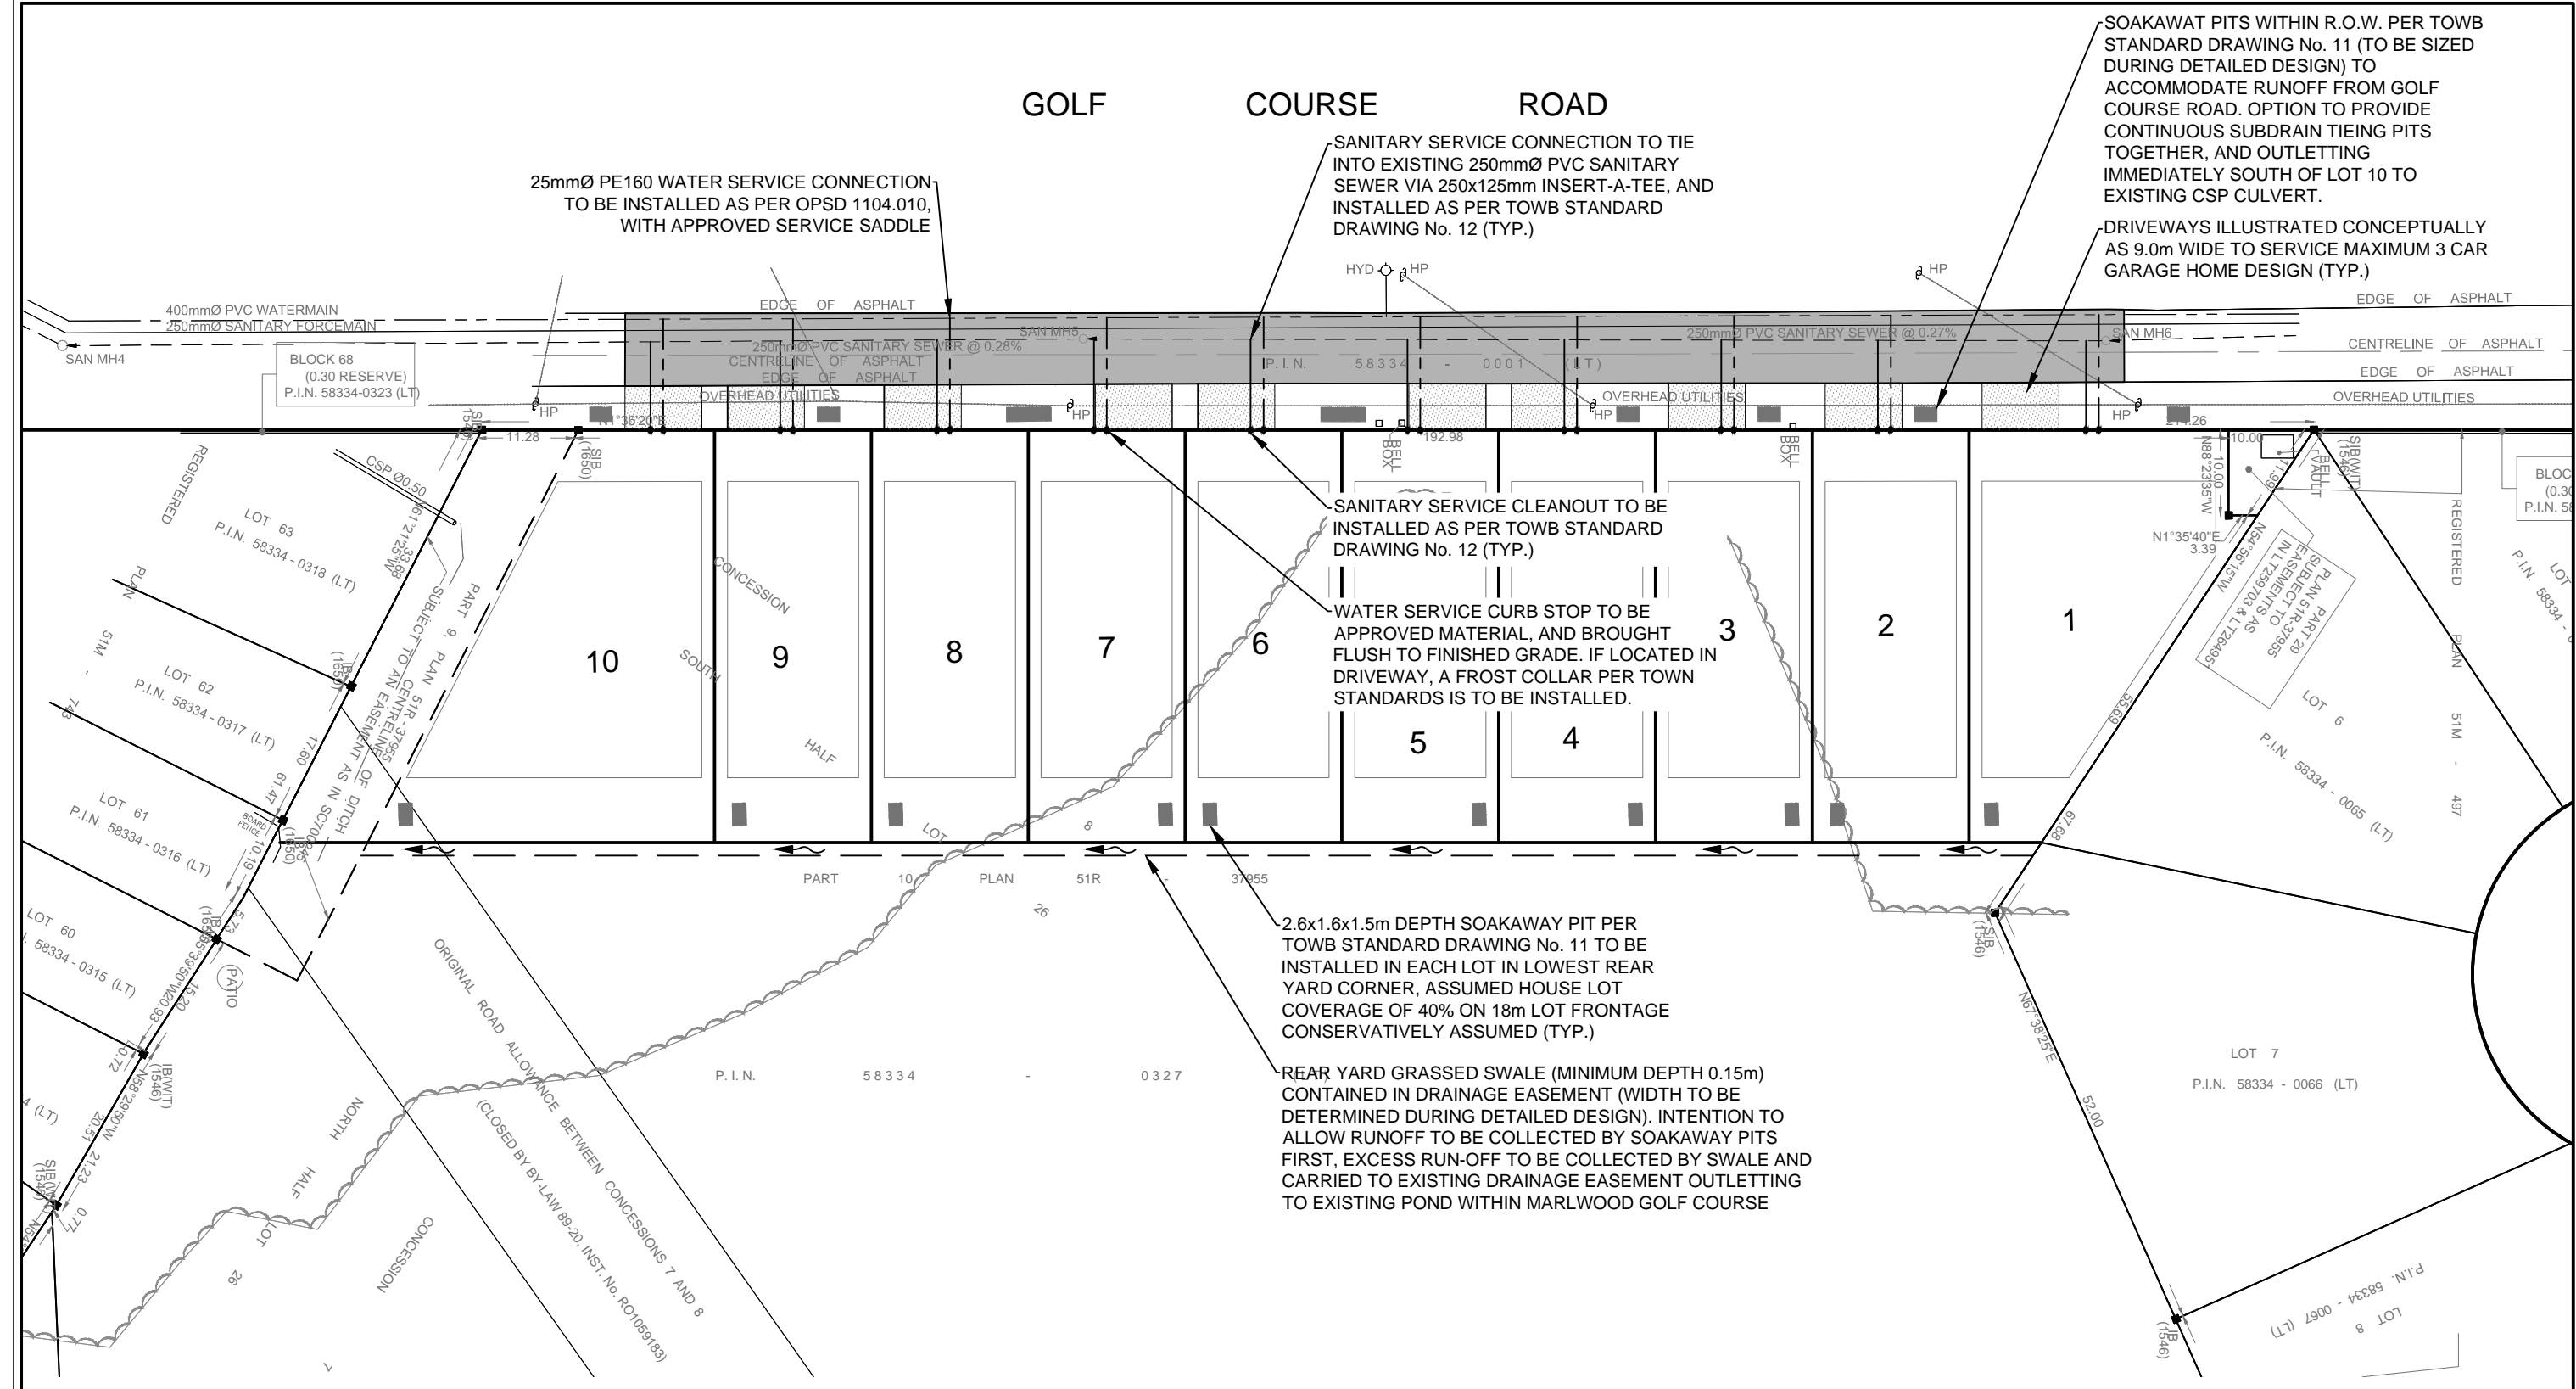
<b>BURNSIDE</b>		<b>MARLWOOD (10 LOTS)</b>	
Client <b>TPC MARLWOOD INC.</b>		PRELIMINARY UNDERGROUND SERVICING	
Figure Title	Drawn	Checked	Date
	KAG	EDT	17/04/21
	Scale	Project No.	
	1:750	300039210	
			<b>4</b>

25mmØ PE160 WATER SERVICE CONNECTION TO BE INSTALLED AS PER OPSD 1104.010, WITH APPROVED SERVICE SADDLE

SANITARY SERVICE CONNECTION TO TIE INTO EXISTING 250mmØ PVC SANITARY SEWER VIA 250x125mm INSERT-A-TEE, AND INSTALLED AS PER TOWB STANDARD DRAWING No. 12 (TYP.)

WATER SERVICE CURB STOP TO BE APPROVED MATERIAL, AND BROUGHT FLUSH TO FINISHED GRADE. IF LOCATED IN DRIVEWAY, A FROST COLLAR PER TOWN STANDARDS IS TO BE INSTALLED.

Sanitary servicing for the ten proposed lots will be an extension of sanitary laterals from the 250 mm PVC sewer generally running down the centerline of Golf Course Road. Refer to Appendix B, Drawings SW6-RD and FM5-RD for existing 'as-built' conditions. The sewer has sufficient depth to allow for a full basement construction if desired for any of the ten proposed lots. The sewer continues across the entire frontage of the proposed ten lots.

Refer to Drawing Site Servicing Plan (Figure 4) for the proposed sanitary lateral layout.

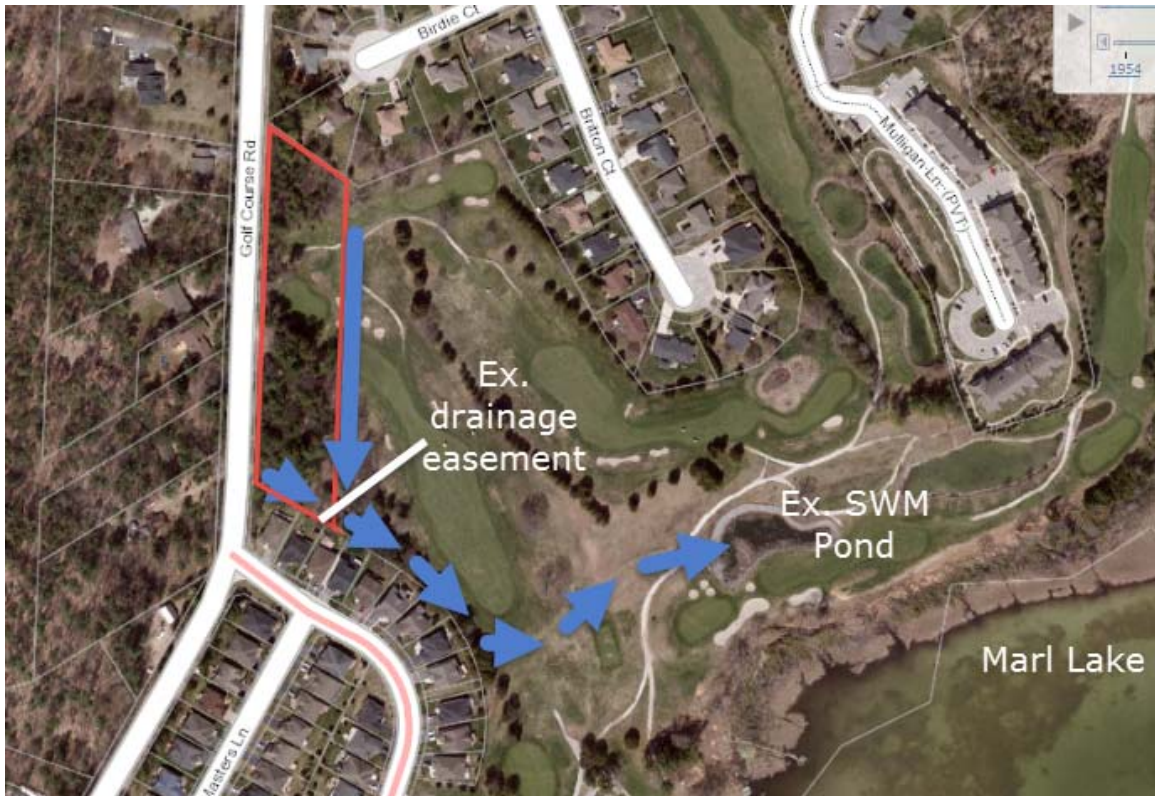
**Image 3 Overland Flow Route**

The site will be graded to provide an overland flow route to the existing golf course overland flow route to the stormwater management facility for the major storm events prior to reaching the outlet to Marl Lake.

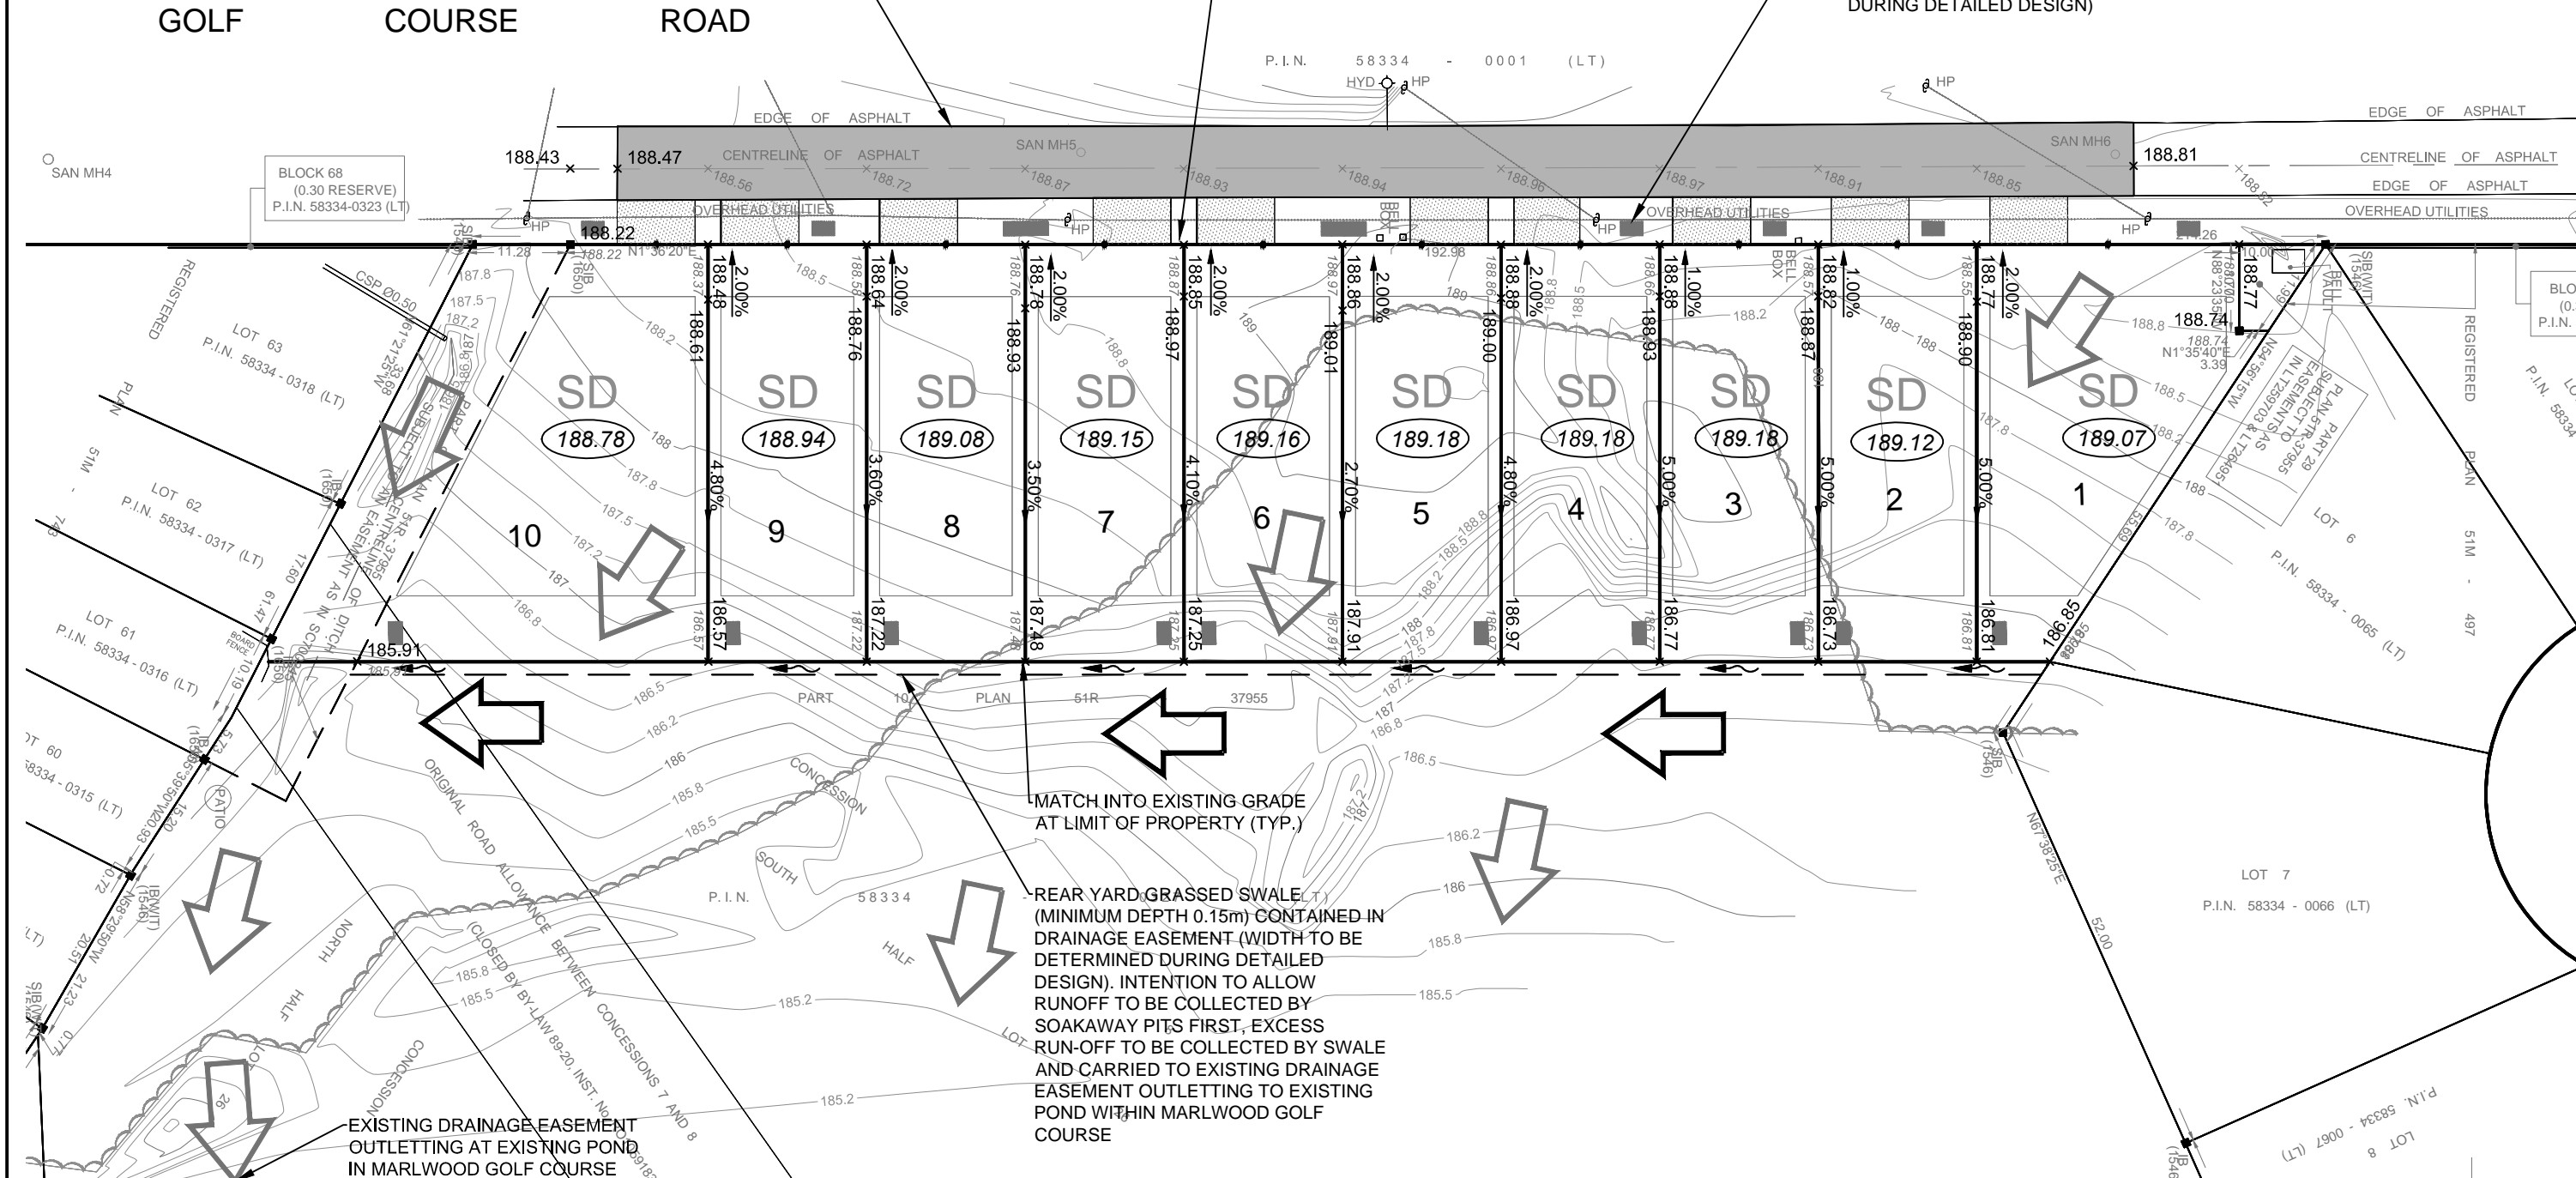
<b>MARLWOOD (10 LOTS)</b> PRELIMINARY GRADING		
		Figure Title	Drawn KAG	Checked EDT
Client <b>TPC MARLWOOD INC.</b>		Scale 1:750	Project No. 300039210	Figure No. <b>5</b>

EXISTING ASPHALT TO BE REMOVED, AND REPLACED TO MATCH EXISTING GRADE FOLLOWING INSTALLATION OF SERVICE CONNECTIONS. PLACEMENT AND COMPACTION OF GRANULARS AND ASPHALT TO FOLLOW TOWB STANDARDS

FINISHED GRADE AT LIMIT OF R.O.W. TO BE RE-GRADED FROM EXISTING, AS REQUIRED, TO MATCH EDGE OF PAVEMENT, IN ORDER TO ASSIST IN ACHIEVING MINIMUM 300mm APRON GRADE ABOVE EXISTING EDGE OF PAVEMENT

FINISHED GRADE AT R.O.W. SOAKAWAY PITS TO BE MINIMUM 0.15m BELOW EDGE OF DRIVEWAY AND GRADE AT LIMIT OF R.O.W. LOCALIZED SHALLOW SWALES/DEPRESSIONS TO BE GRADED BETWEEN DRIVEWAYS TO DIRECT FLOW TO SOAKAWAY PIT (TO BE ILLUSTRATED DURING DETAILED DESIGN)

EXISTING DRAINAGE EASEMENT OUTLETTING AT EXISTING POND IN MARLWOOD GOLF COURSE

MATCH INTO EXISTING GRADE AT LIMIT OF PROPERTY (TYP.)

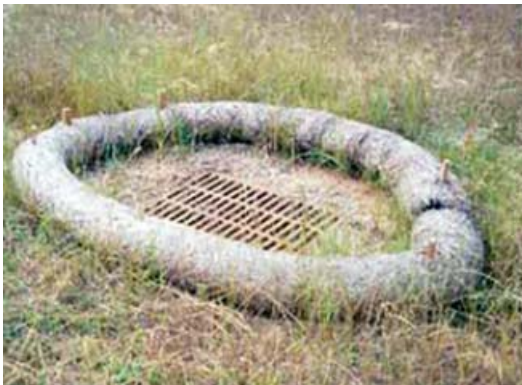
### Image 4 Sediment Containment Ring

All proposed catchbasins and area drains on site shall have the underside of the grates covered with Terrafix 240R non-woven geotextile material and include a sediment containment ring around these inlets during construction period to protect them from filling with sediment. The Contractor shall regularly clean the sediment and debris filtered out by these structures. The Contractor shall remove and dispose of the geotextile material at the end of the construction period.

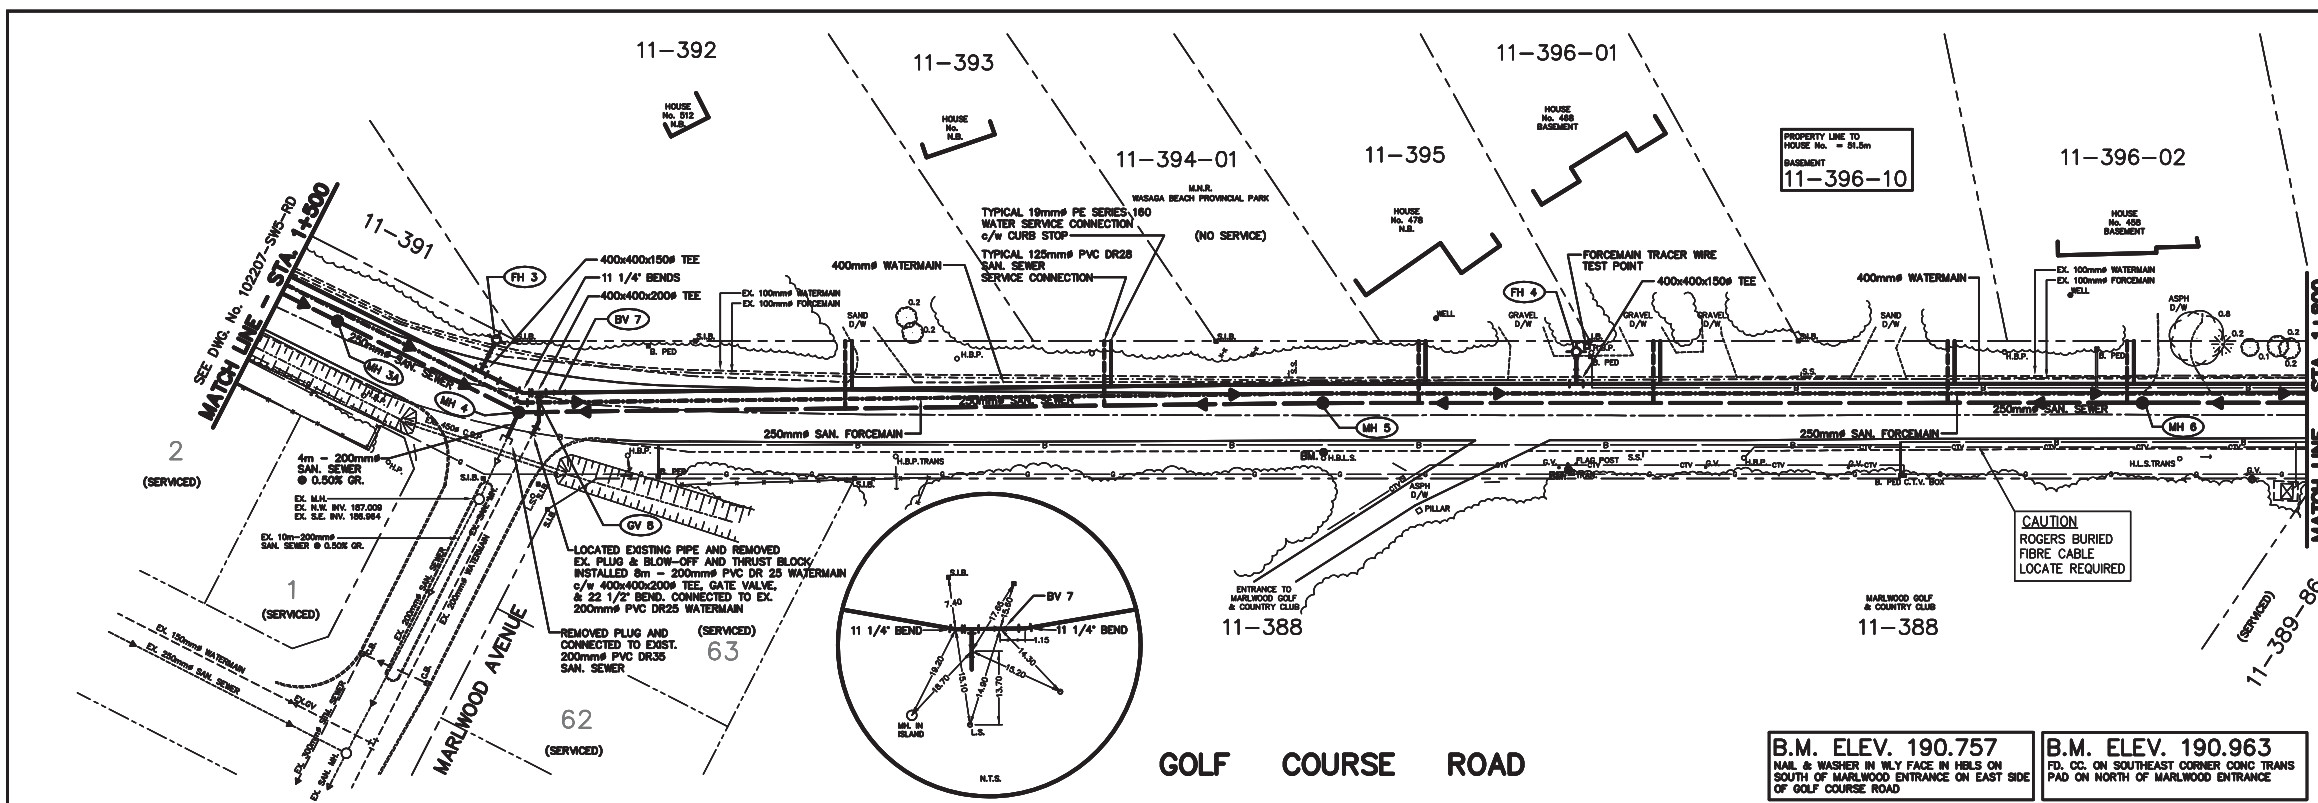
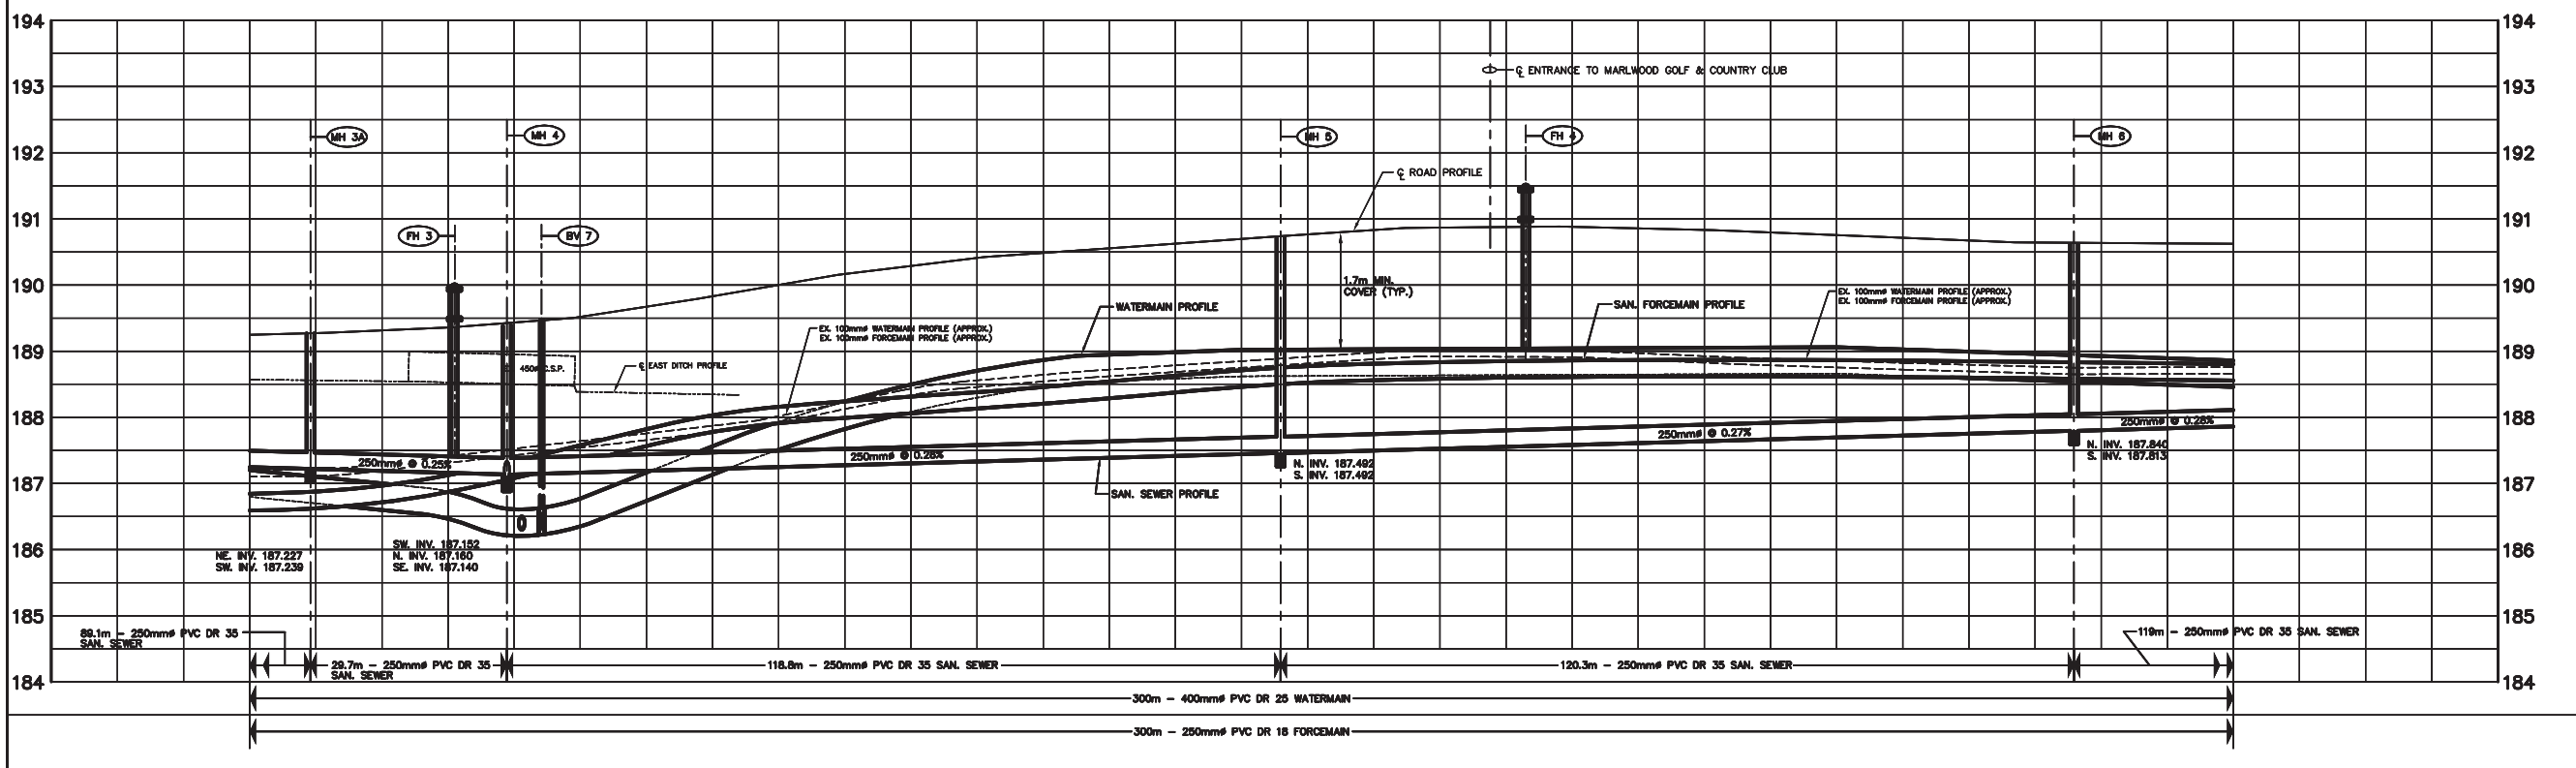
**PLAN & PROFILE**  
GOLF COURSE ROAD  
STA. 1+500 TO STA. 1+800

B.M. ELEV. 190.757  
NAIL & WASHER IN WLY FACE IN HELLS ON SOUTH OF MARLWOOD ENTRANCE ON EAST SIDE OF GOLF COURSE ROAD

B.M. ELEV. 190.963  
FD. CC. ON SOUTHEAST CORNER CONC TRANS PAD ON NORTH OF MARLWOOD ENTRANCE

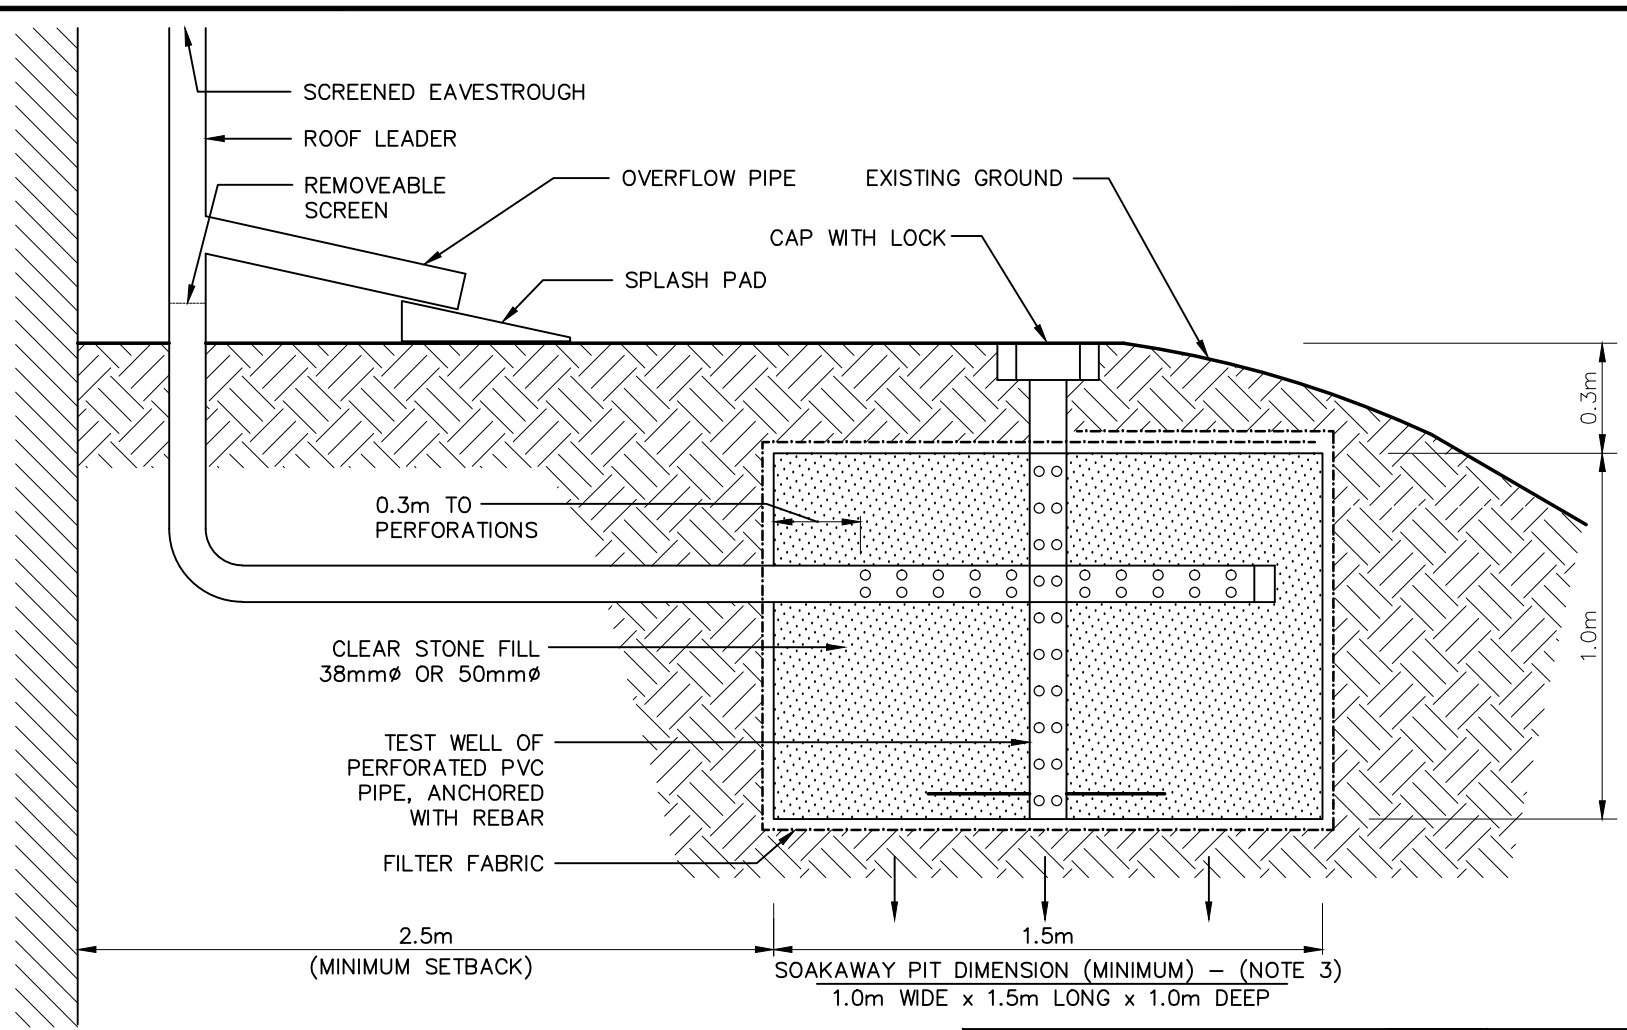
1. FILTER FABRIC TERRAFIX 270R OR EQUAL.
2. PROVIDE MINIMUM 0.5m CLEARANCE TO WATER TABLE FROM BOTTOM OF PIT.
3. SOAKAWAY PIT DIMENSIONS SHALL BE SIZED PER DESIGN ENGINEER RECOMMENDATION.
4. SOAKAWAY PIT TO BE INSPECTED BY DEVELOPER'S ENGINEER PRIOR TO BACKFILL.
