**Functional Servicing and Stormwater  
Management Report  
Proposed 10 Lot Residential  
Development  
Golf Course Road**

**TPC Marlwood Inc.  
31 Marlwood Avenue  
Wasaga Beach ON L9Z 1S8**

**R.J. Burnside & Associates Limited  
3 Ronell Crescent  
Collingwood ON L9Y 4J6 CANADA**

**July 6, 2017  
300039210.0000**

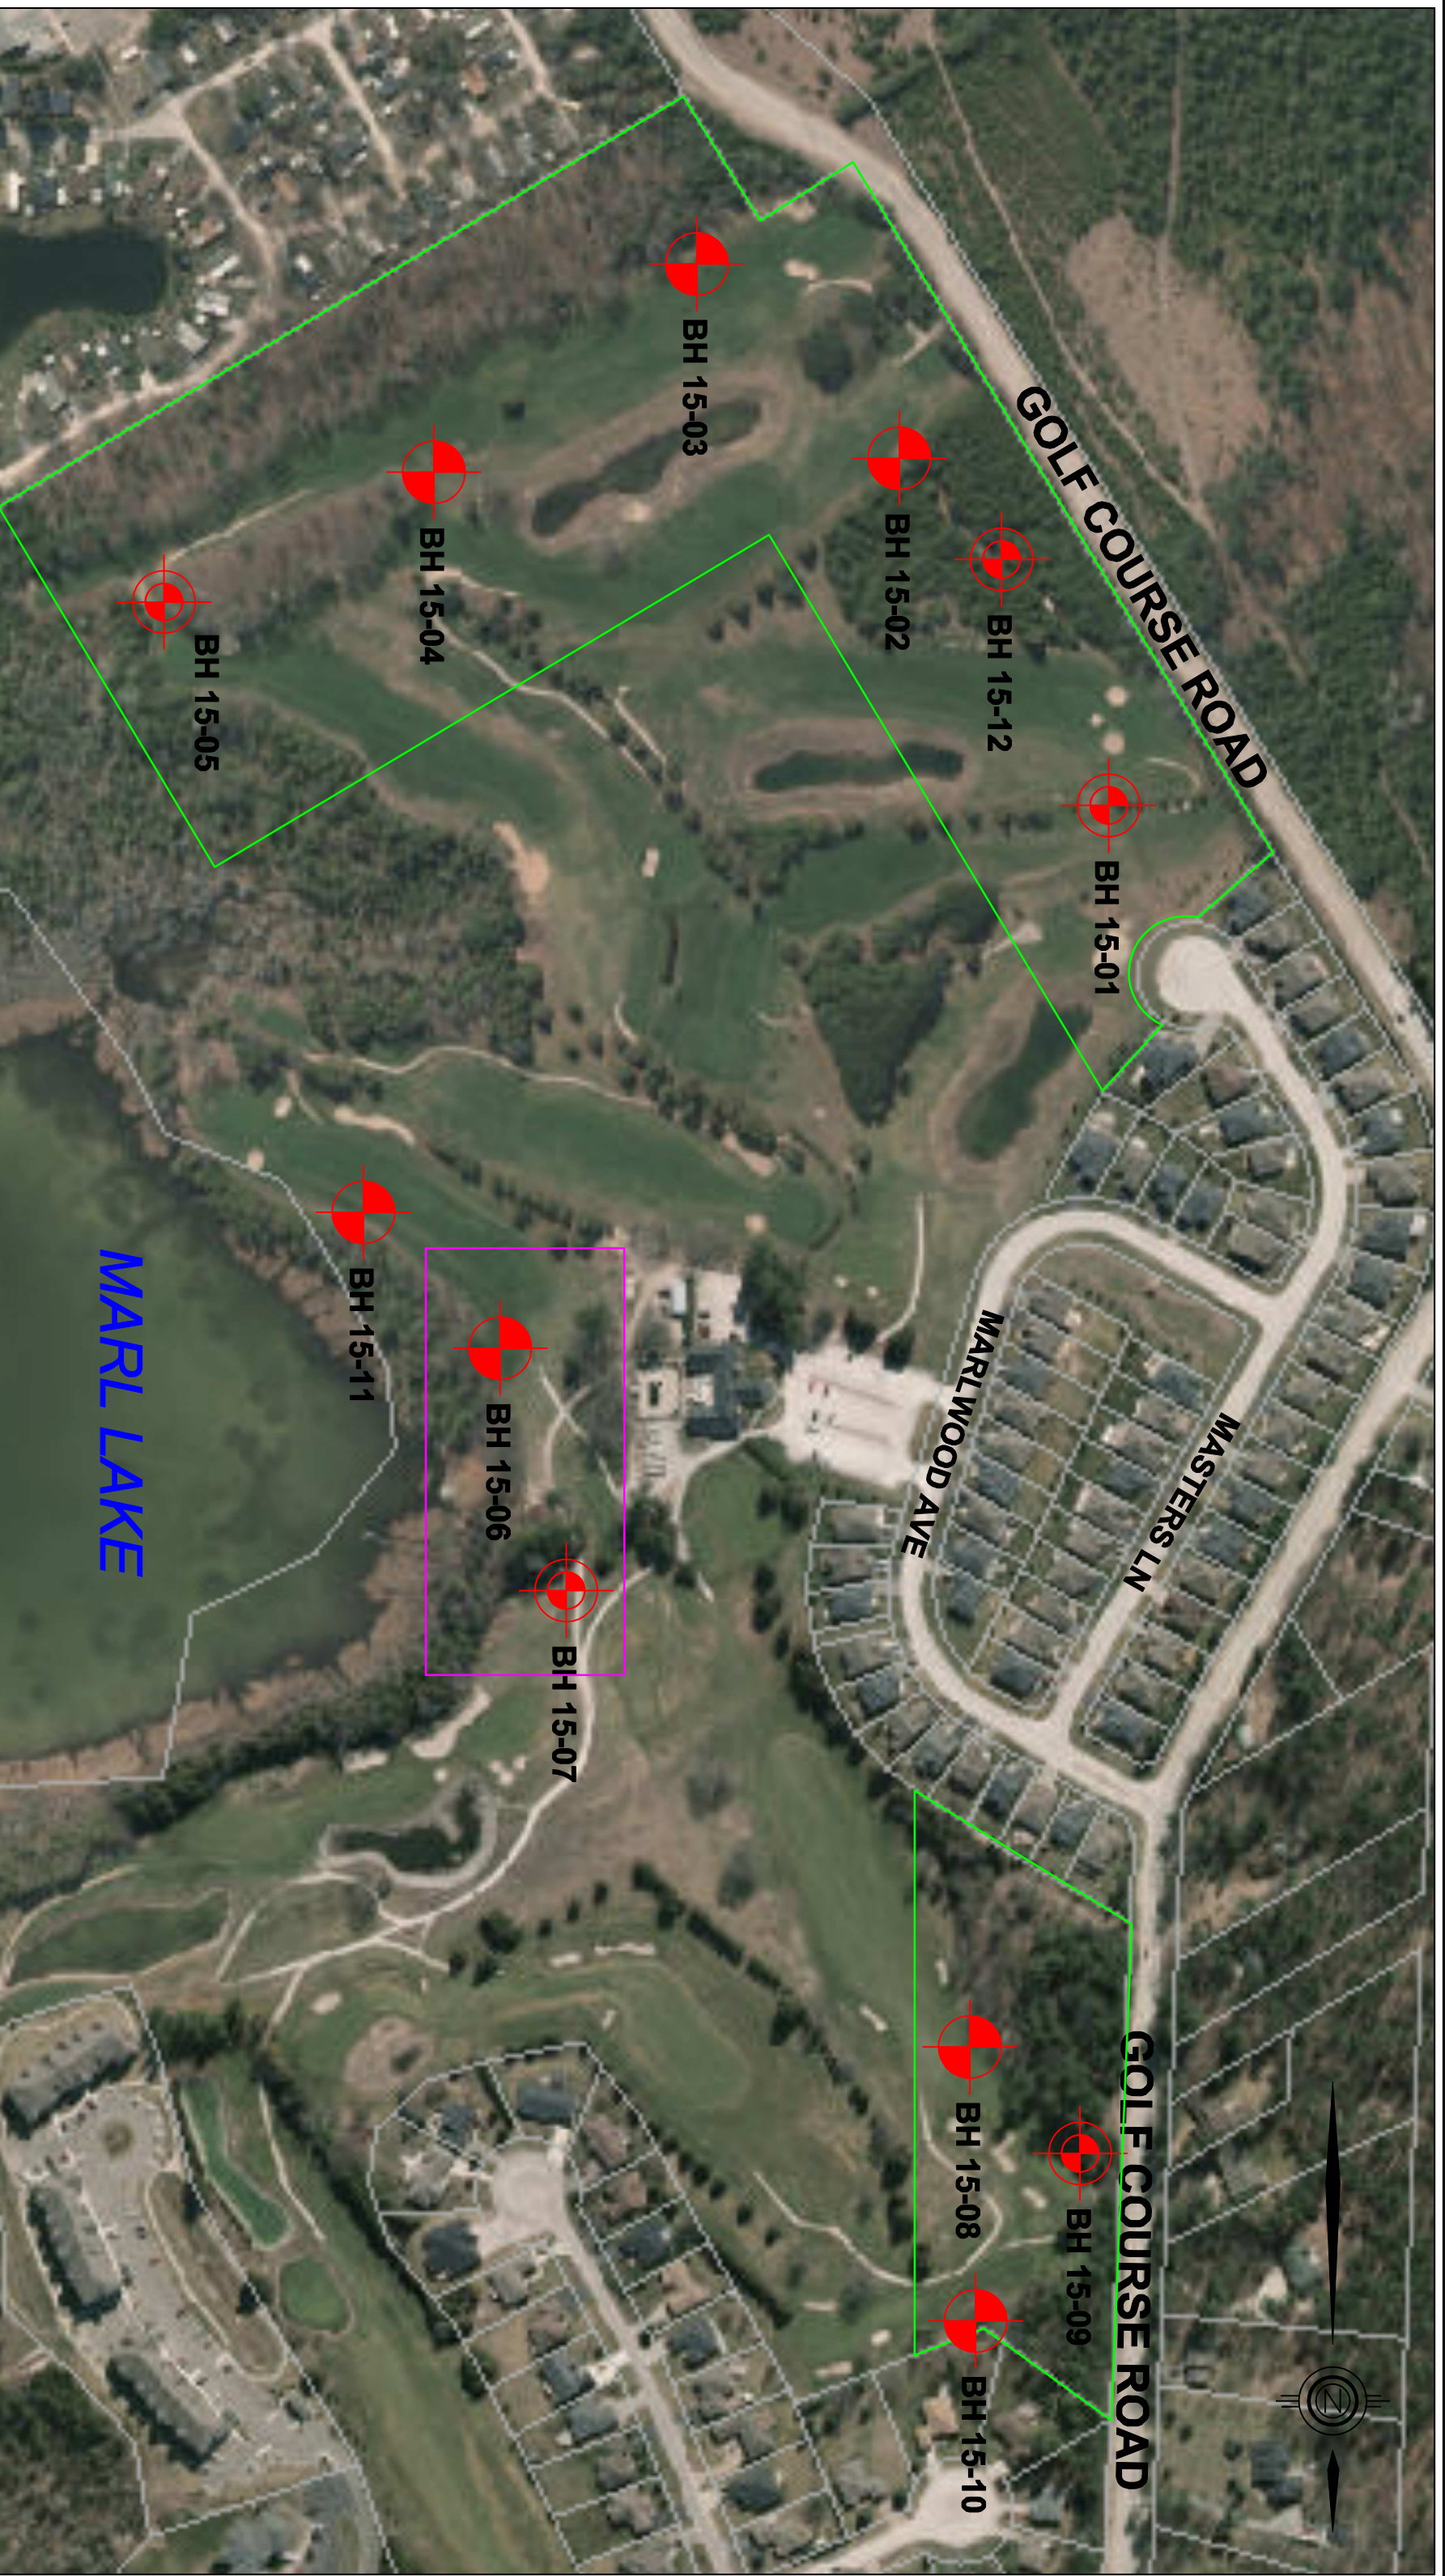
Client:	MARLWOOD GOLF AND COUNTRY CLUB	Project No.:	10002397	Figure No.:	1
Drawn:	MV	Approved:	GJ	BOREHOLE LOCATION PLAN	
Date:	NOVEMBER, 2015	Scale:	AS SHOWN	PRELIMINARY GEOTECHNICAL INVESTIGATION 31 MARLWOOD AVE, WASAGA BEACH, ONTARIO	
Original Size:	TABLOID	Rev.:	1

The borehole locations are shown on Drawing 1. Notes on soil sample descriptions are presented on Enclosure 1 in Appendix A. The subsurface conditions at the boreholes (BH15-01 through BH15-12) are presented on the individual borehole logs (Enclosures 2 to 13) enclosed in Appendix A, and are summarized in the following paragraphs.

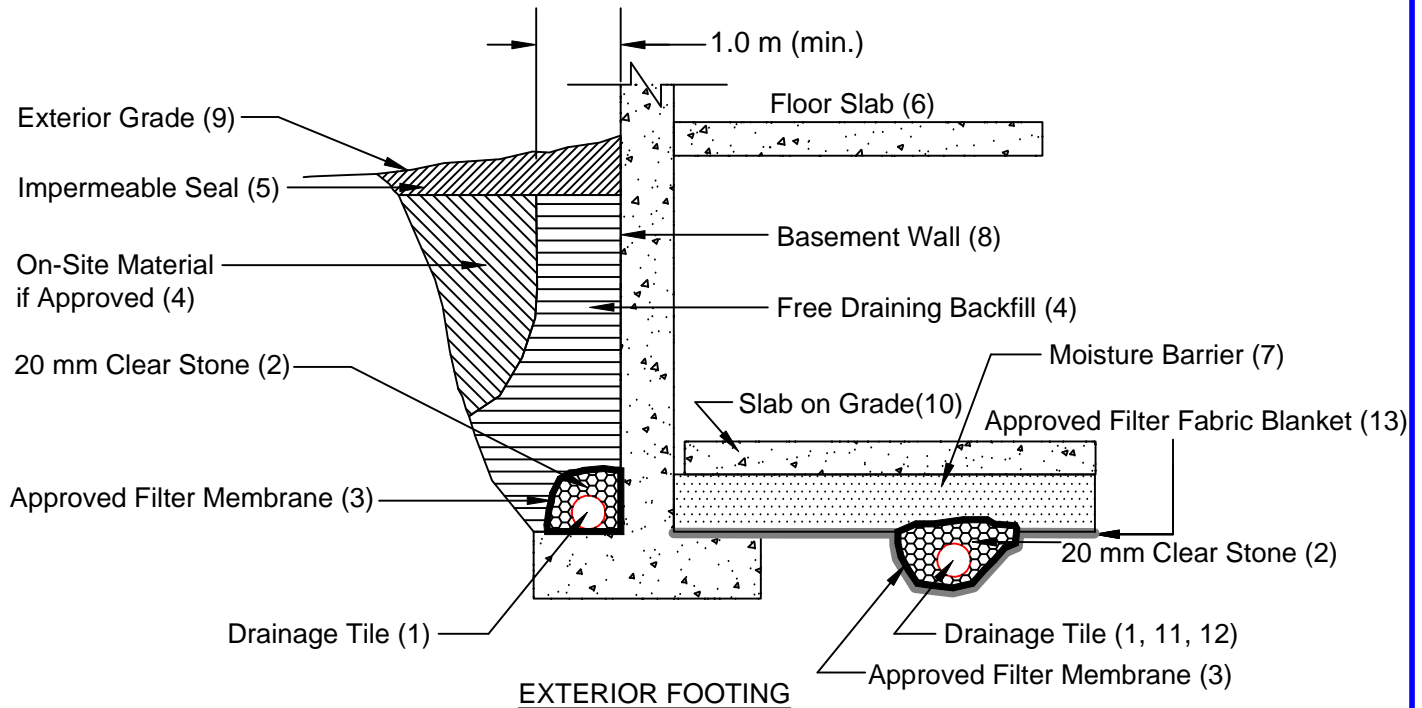
1. Drainage tile to consist of 100 mm (4") diameter weeping tile or equivalent perforated pipe leading to a positive sump or outlet.
2. 20 mm (3/4") clear stone - 150 mm (6") top and side of drain. If drain is not on footing, place 100 mm (4 inches) of stone below drain .
